# CMOM Annual Report 2022

## **Capacity, Management, Operations and Maintenance (CMOM) Plan Overview**

In accordance with National Pollutant Discharge Elimination System (NPDES) Permit No. NM0022250 (Permit), the Albuquerque Bernalillo County Water Utility Authority (Water Authority) prepared this Capacity, Management, Operations and Maintenance (CMOM) Plan. The Permit was renewed in CY2019 with an effective date of December 1, 2019.

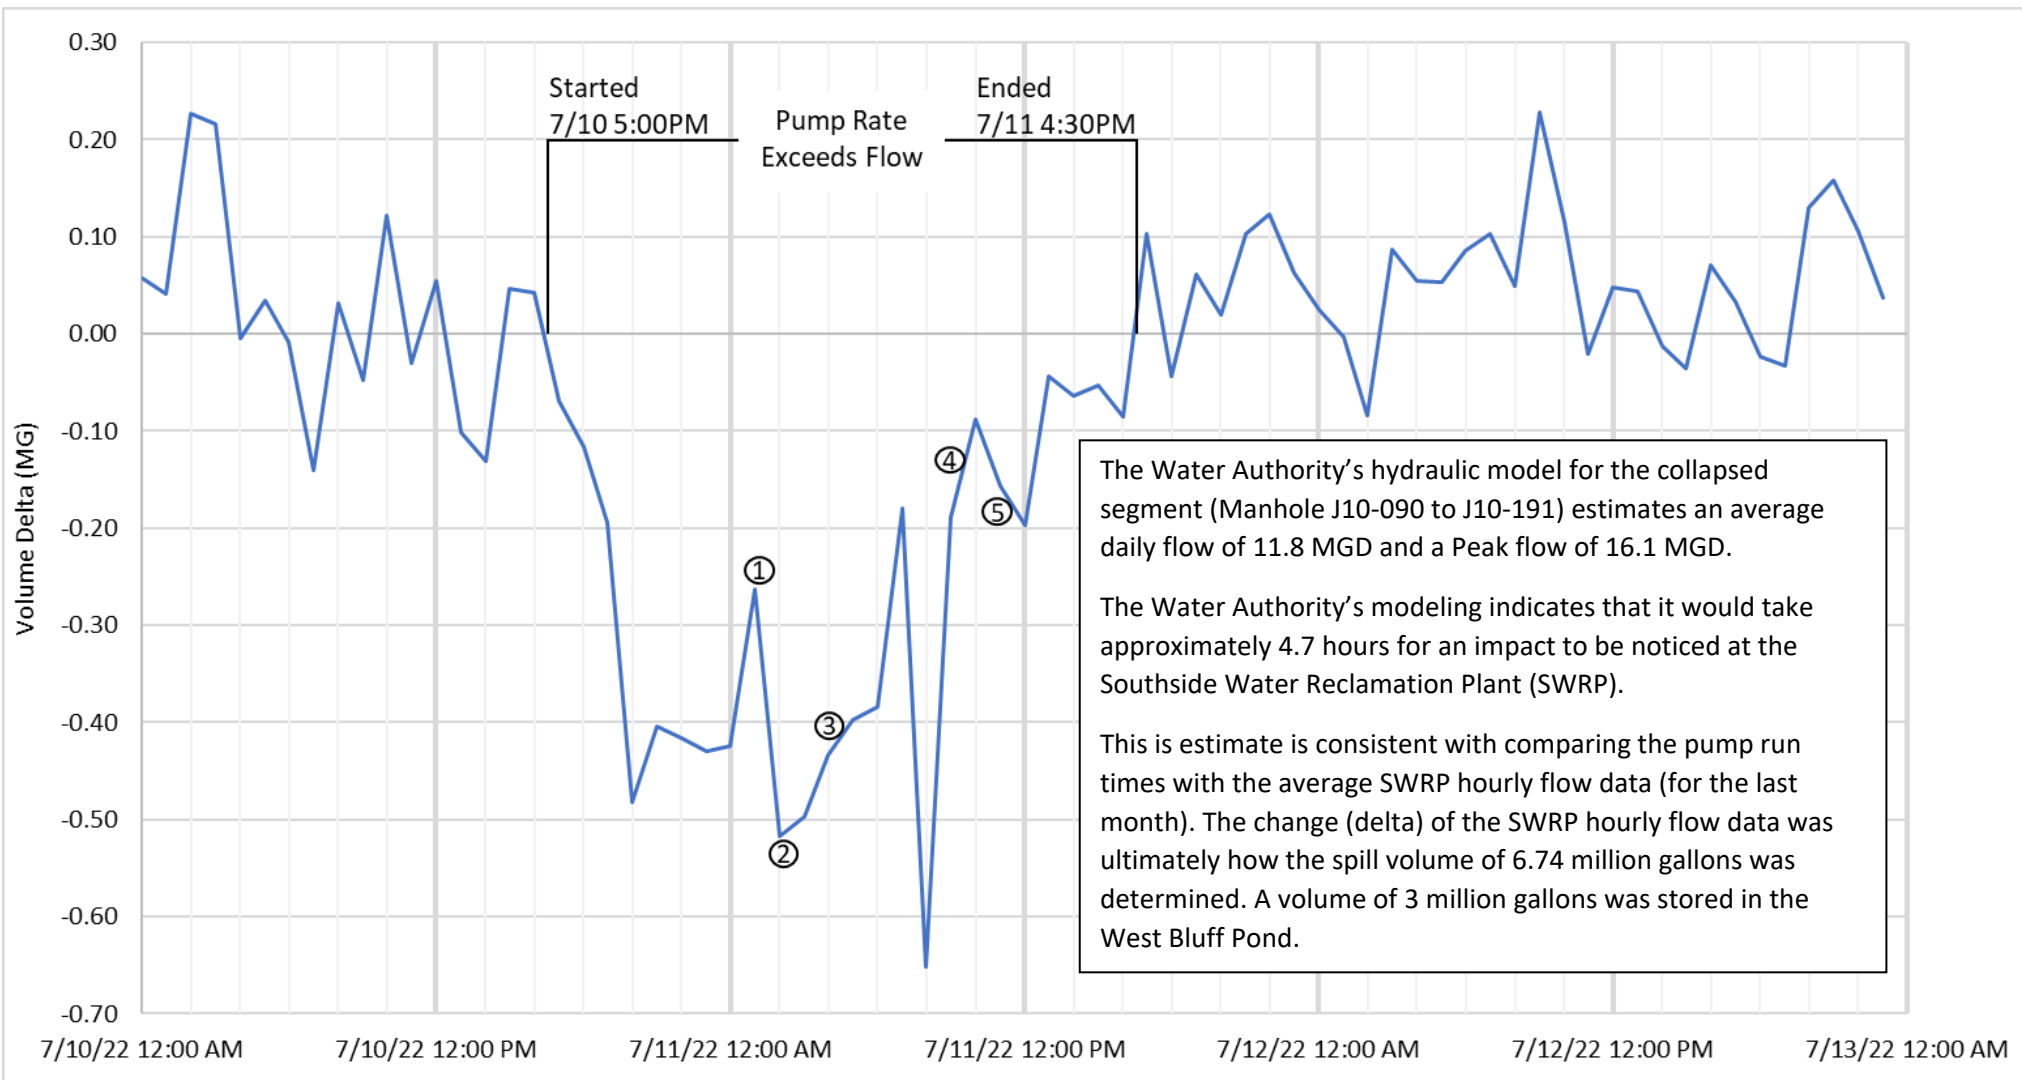
**Attachment B – SWRP Hourly Flow Data Comparison and Bypass Pumping Capacity Table**

TLC is the current On-Call contractor tasked with responding to interceptor emergencies. TLC responded and installed its pumping capacity. The Chief Engineer identified that this pumping rate was inadequate and immediately, and unprecedentedly, called in a second On-Call contractor. RMCI brought additional pumps, which, in sum, pump more than the largest interceptor flow in the Water Authority's system.

<u>Event (as identified on graph)</u>	<u>Interim Bypass Pumps</u>	<u>Time on 07/11/2021</u>	<u>Estimated Pump Capacity (MGD)</u>
1	(1) 6" Pump Running	1:00 AM	1.5
2	(2) 6" Pumps Running	2:00 AM	3
3	(4) 6" Pumps Running	4:00 AM	6
4	(1) 12" Pump and (4) 6" Pumps Running	9:00 AM	17.5
5	(2) 12" Pumps and (4) 6" Pumps Running	11:00 AM	29.0

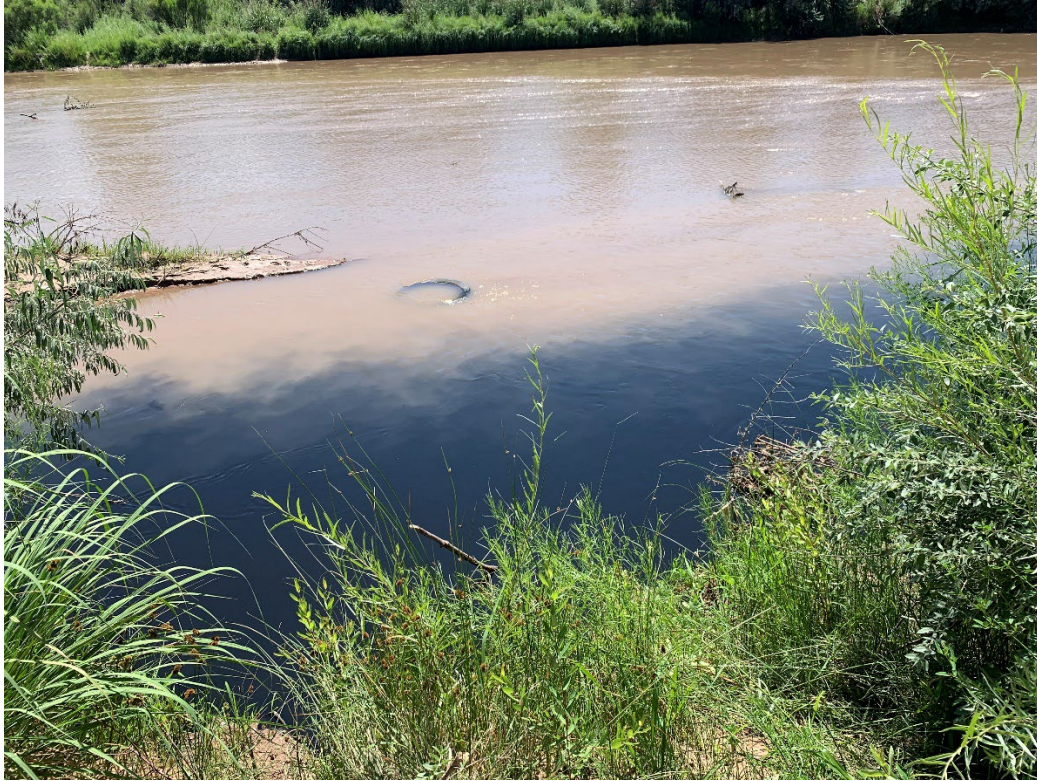
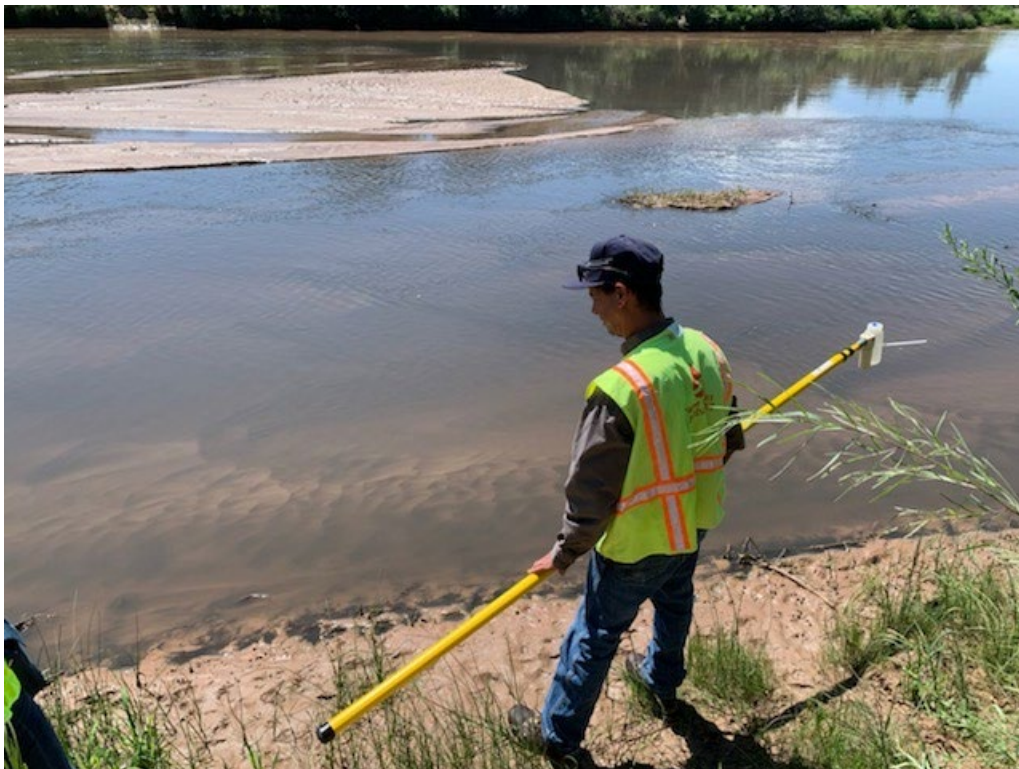
1. Storm outfall and sample collection downstream

Cleanup of spilled sewage on streets and sidewalks continues today. Overflows of sewage into the Rio Grande via the storm drain system have ceased, and the Water Authority is following EPA and New Mexico Environment Department requirements to determine the extent of the permit violations caused by the spill.

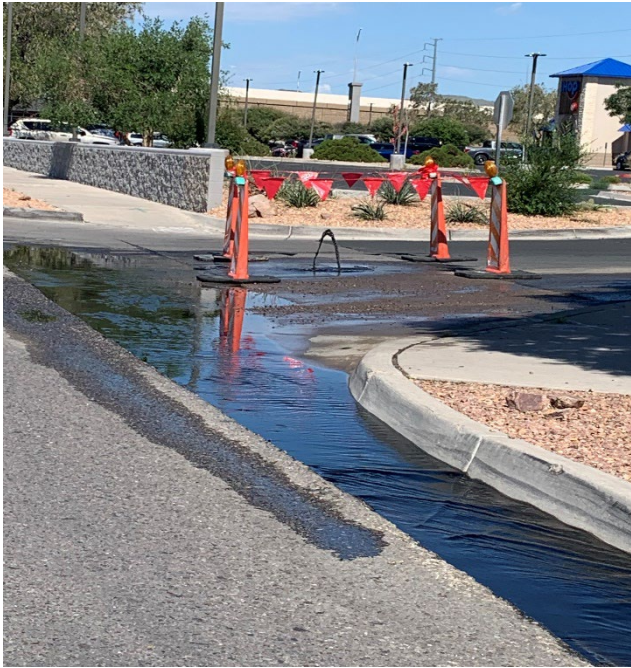
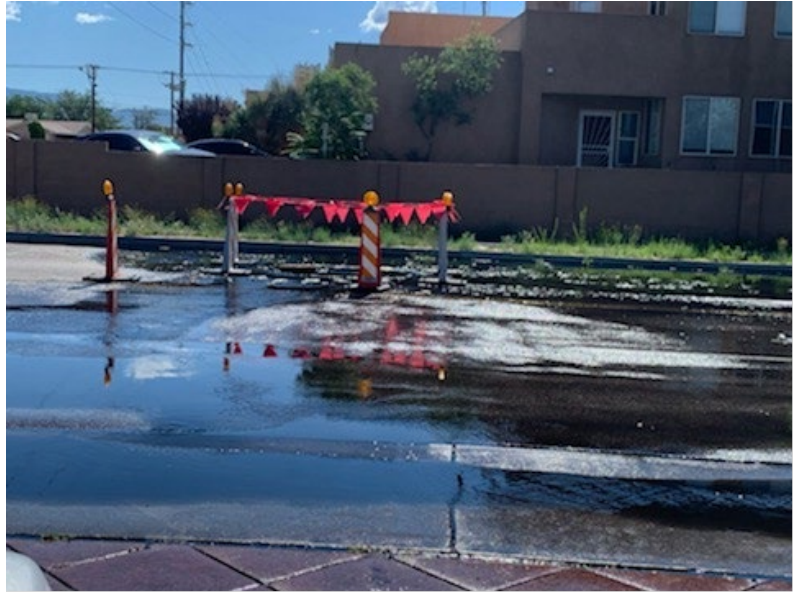
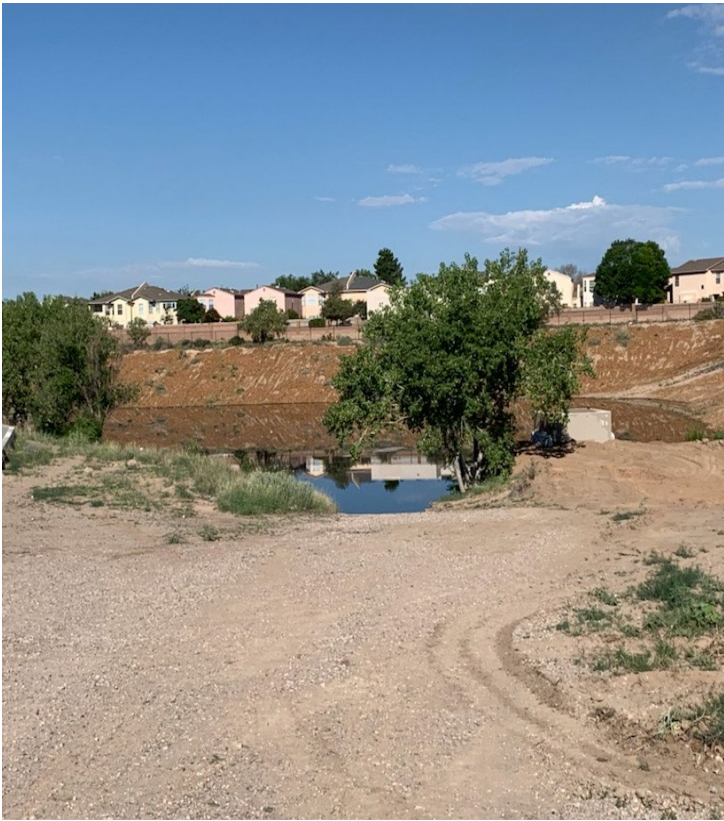
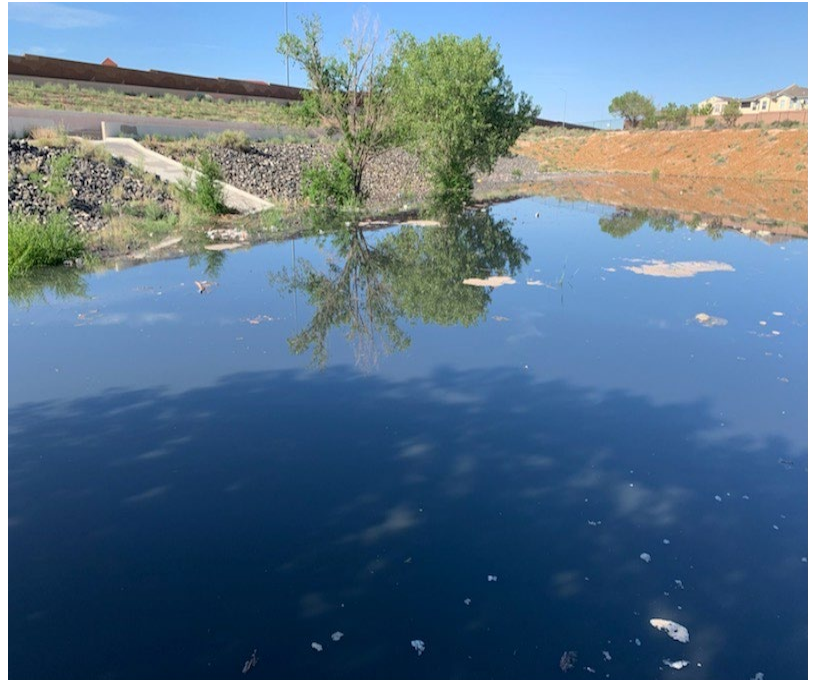
## 2. Street flow and storm pond

Approximately 3 MG of sewage was spilled to and contained by the West Bluff Pond. This Pond is a water quality feature owned and managed by AMAFCA. AMAFCA temporarily closed off the Pond outlet, retaining this sewage and preventing its release to the Rio Grande. AMAFCA also closed off the Pond to through-flow of storm water, however, during run-off events the pond does “float” with the drainage system and will slowly fill to an equilibrium elevation. Two storms have occurred since the sewage was trapped and slow flow into the Pond was observed during each storm event.

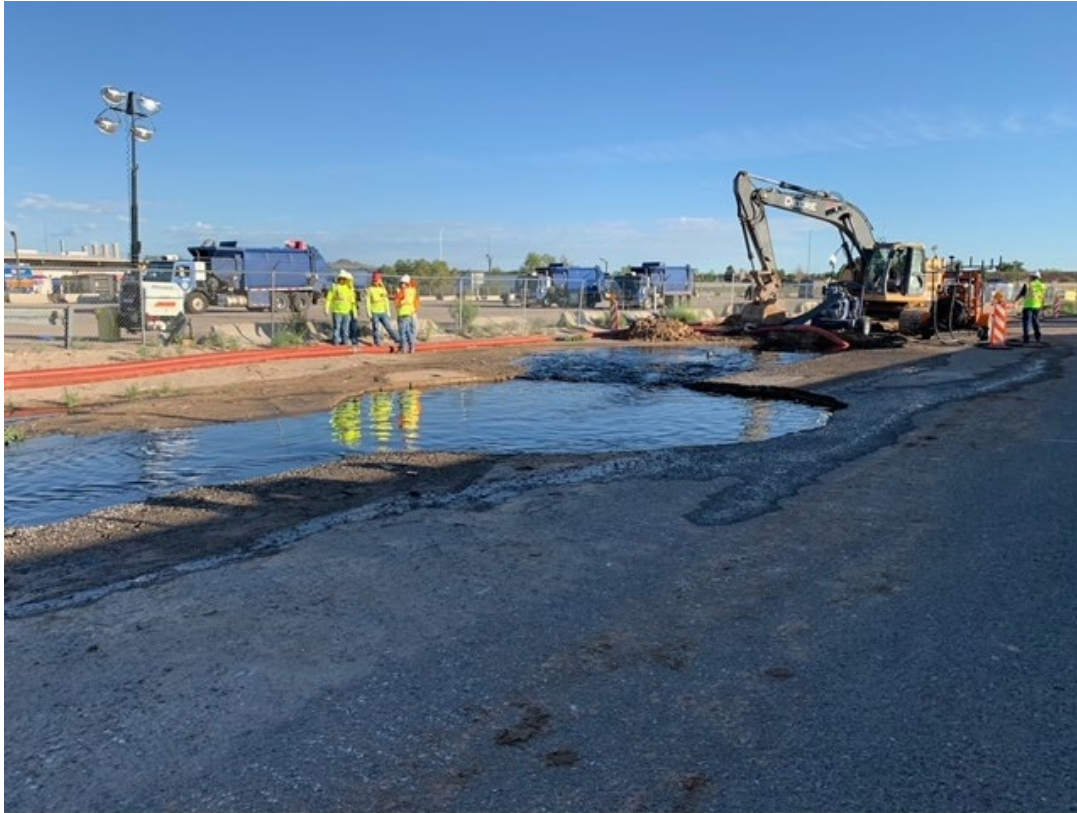
### 3. Sink hole

The sanitary sewer overflow (SSO) that started on July 10, 2022, was caused by a structural collapse of the 48-inch pipe between manholes J10-090 (upstream) and J10-191 (downstream). Due to the topography and the disrupted flow, spills occurred over a large area about 3 miles between the southernmost (downstream) and northernmost (upstream) spills. This was a 6.7 million gallon SSO where 3.7 million gallons were discharged to the river and the Albuquerque Bernalillo County Water Utility Authority (Water Authority) will diligently take steps to prevent it from recurring.

The Water Authority has initiated the rehabilitation of the immediately downstream portion of the same interceptor that collapsed. By-pass pumping commenced on July 7 for this downstream project. The Water Authority believes that this by-pass pumping surcharged the upstream interceptor that collapsed. The interceptor apparently was corroded, and surcharging saturated the soil above the interceptor. The soil lost cohesion and collapsed into the pipe, blocking all flow.

**JULY 12, 2022**—A temporary bypass pumping system is in place and successfully diverting flows around a collapsed sewer pipe that caused backups and overflows on Albuquerque's West Side on Sunday and Monday of this week. Construction of a permanent bypass pump system to be used while the damaged pipeline is under repair will be ongoing through the end of the week.
