# Rio Grande Sewer Repair Photographs -1954

Repair by Shufflebarger Contractor as ordered by the City Commission on the  
recommendation of E.O. Betts City Engineer

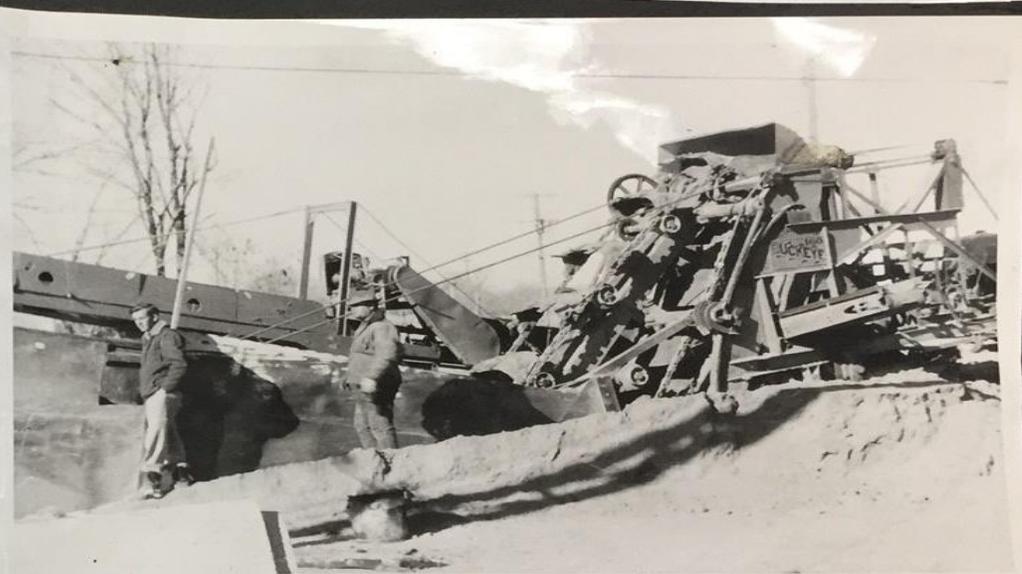
2-12-54

Miller Smith Boot - Used to  
relay 18" line No from Indian School  
Rd. to Zikart Rd.

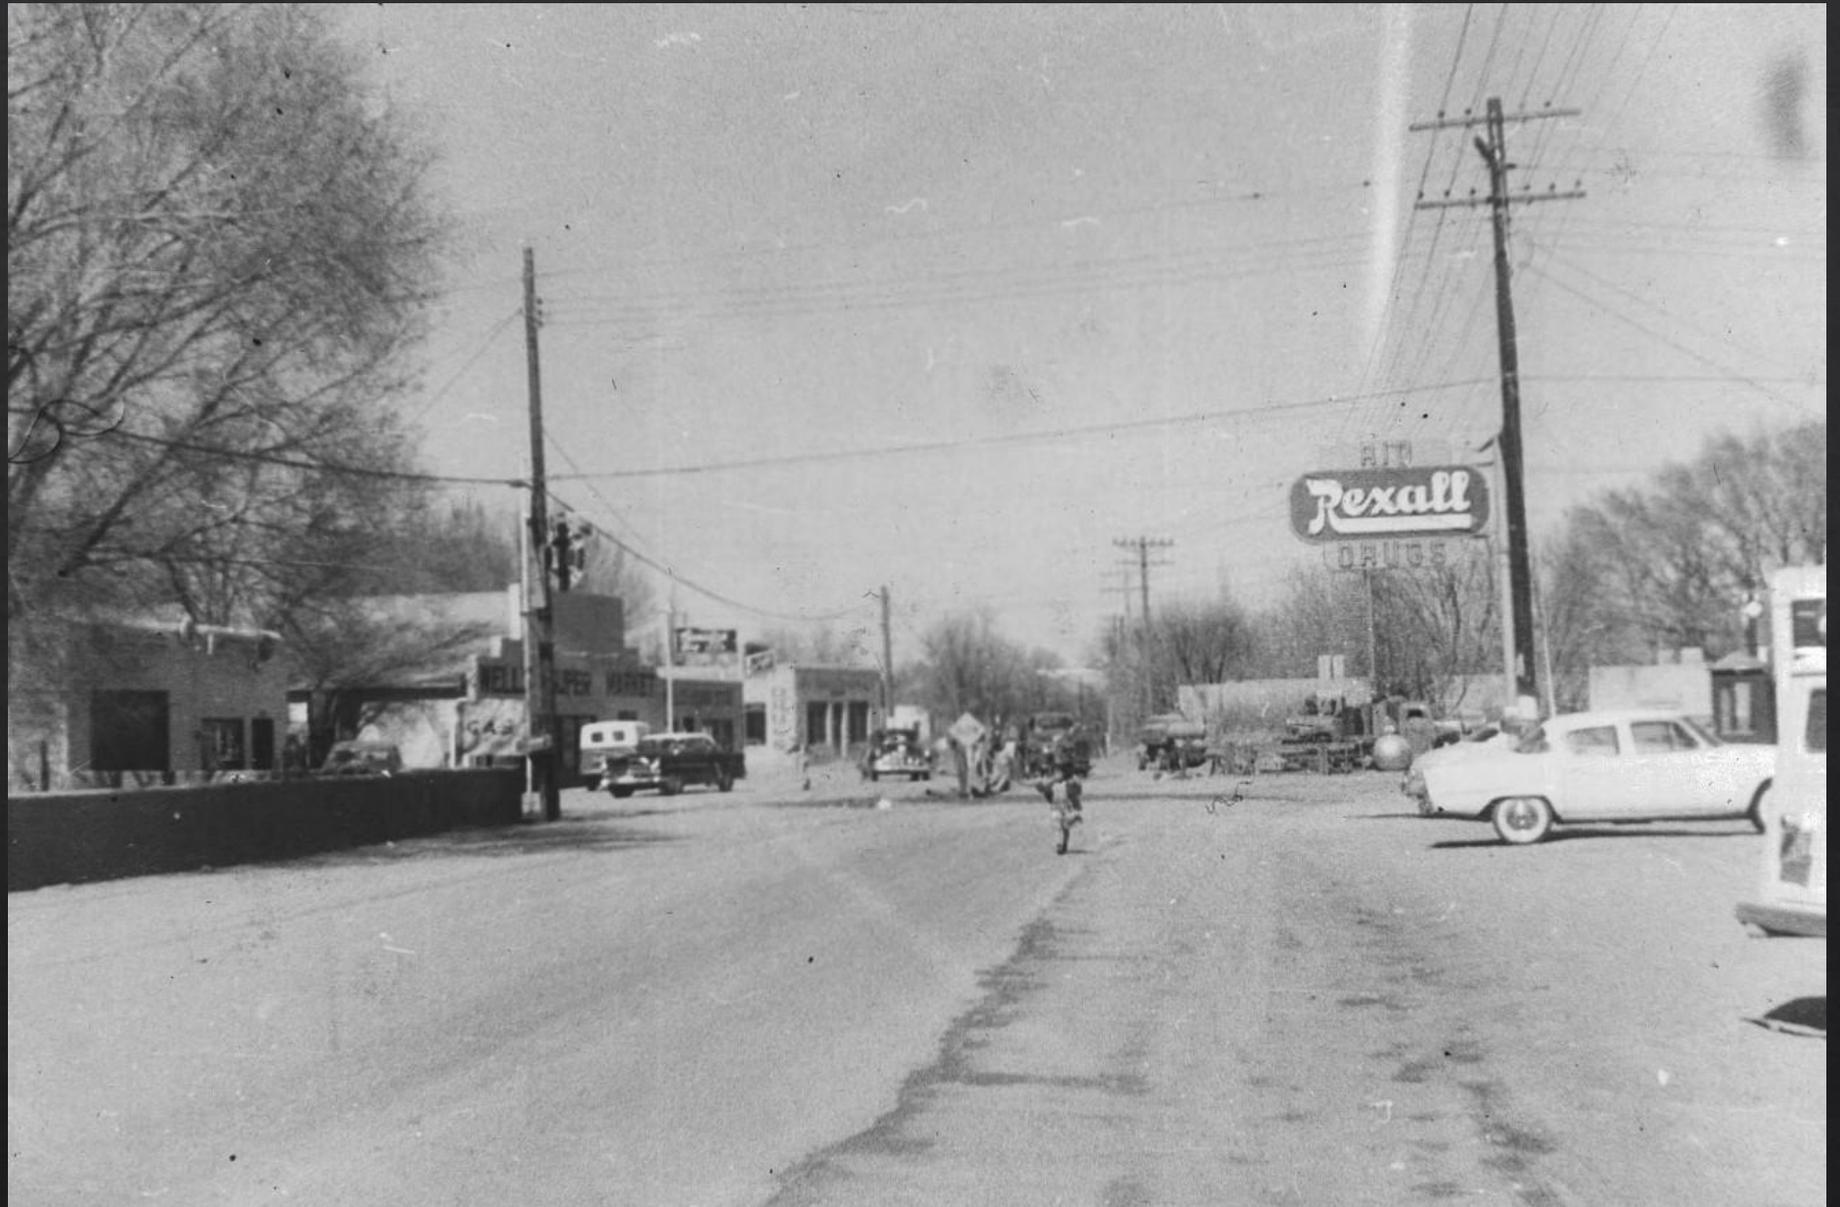
2/18/54

Rio Grande Road  
Blocked –  
Northbound traffic  
was routed East on  
Indian School Rd.

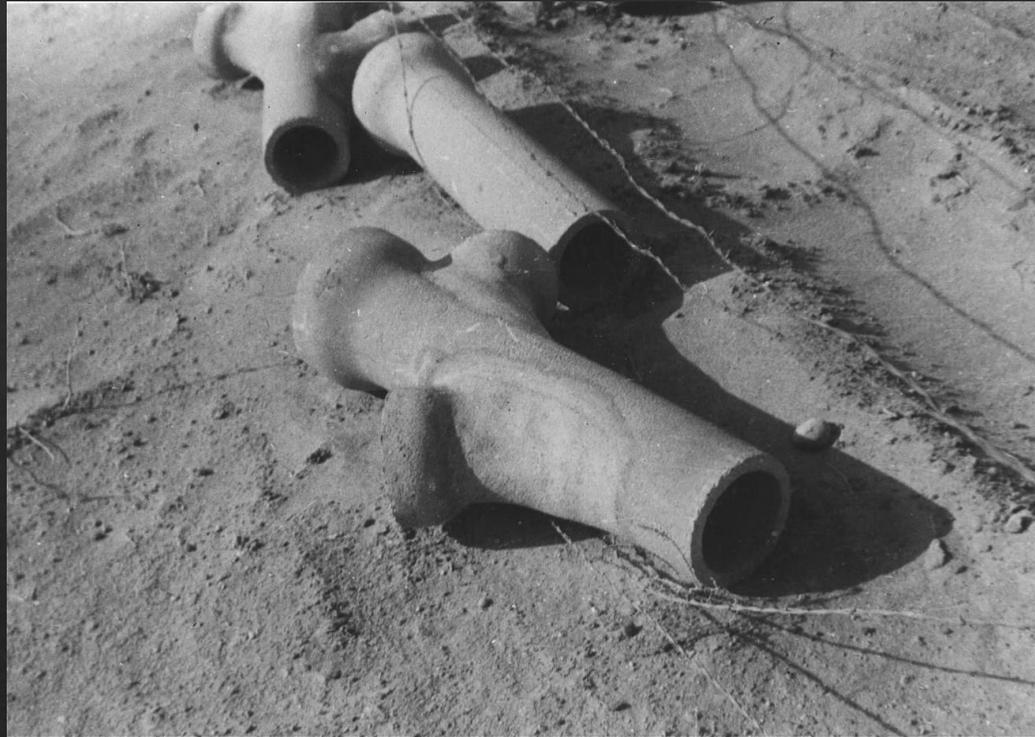
2/25/54

This type of Concrete Y. was used in all repairs – Y is 4'x8" with 3 possible connections.

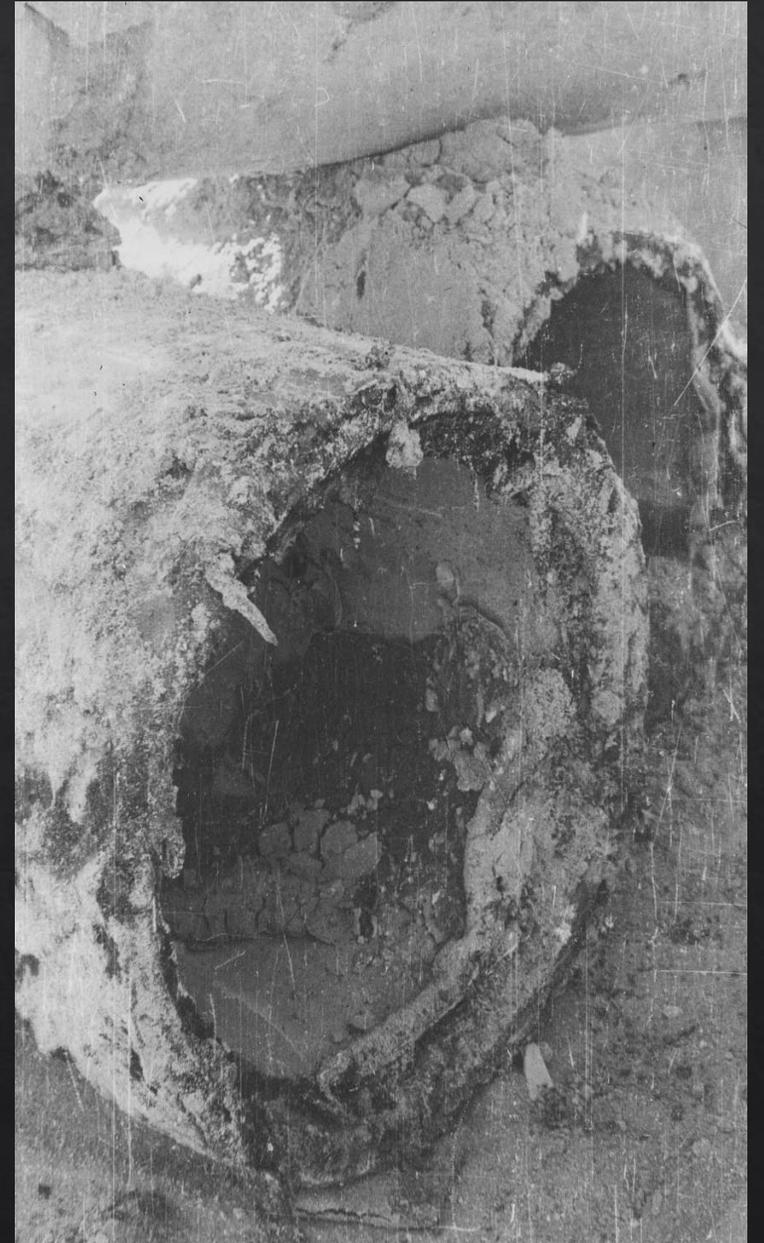
2/20/54

Joint of 10" pipe removed from the relayed Montoya line – This section of line from Thompson Rd. No. to a point 220 'ft. No. of Mountain Rd. was removed and replaced because of the use of Mastic compound, an oily-tar like material, was not satisfactory for water tight construction.

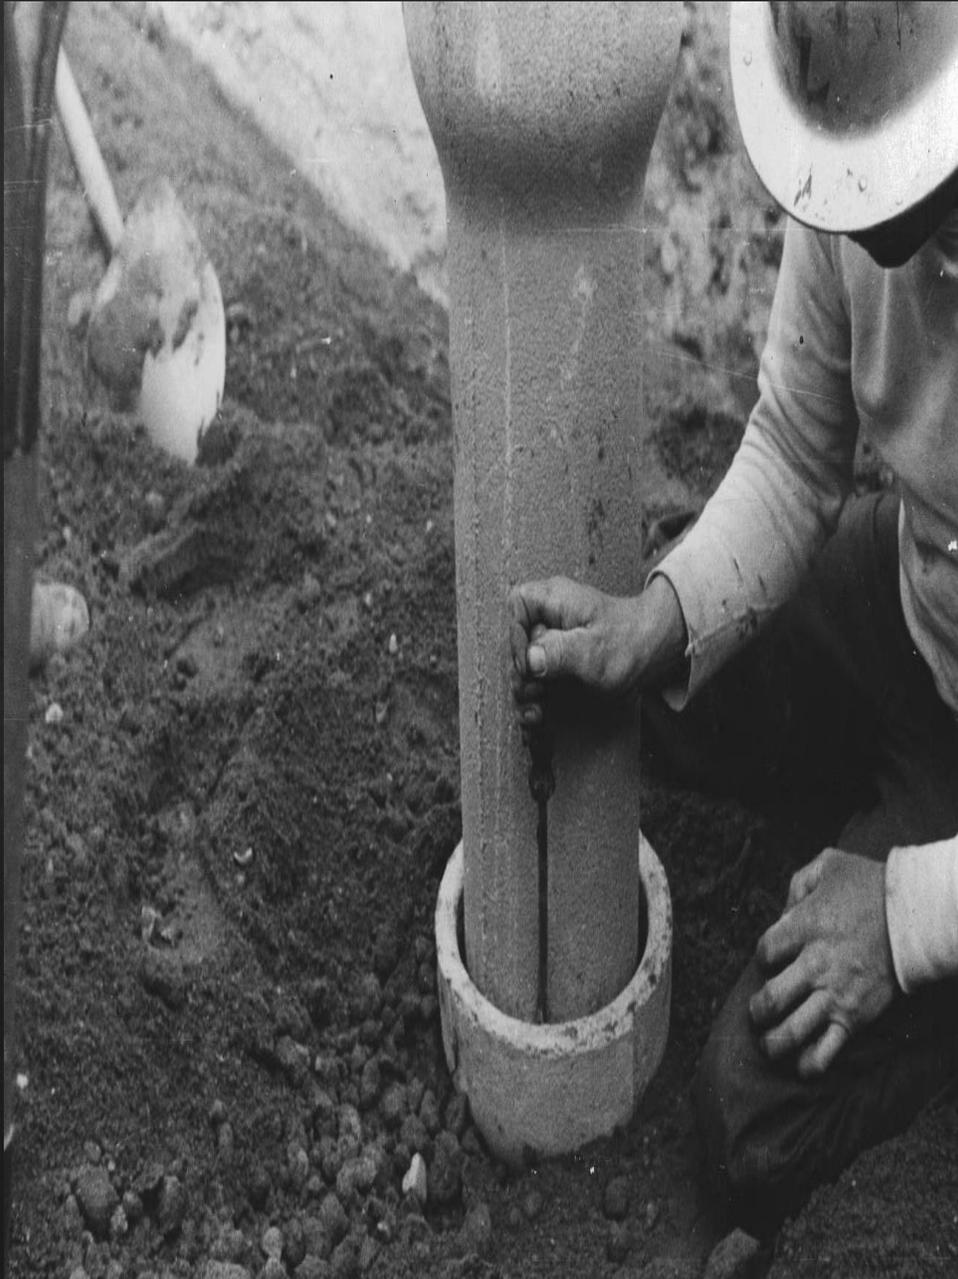
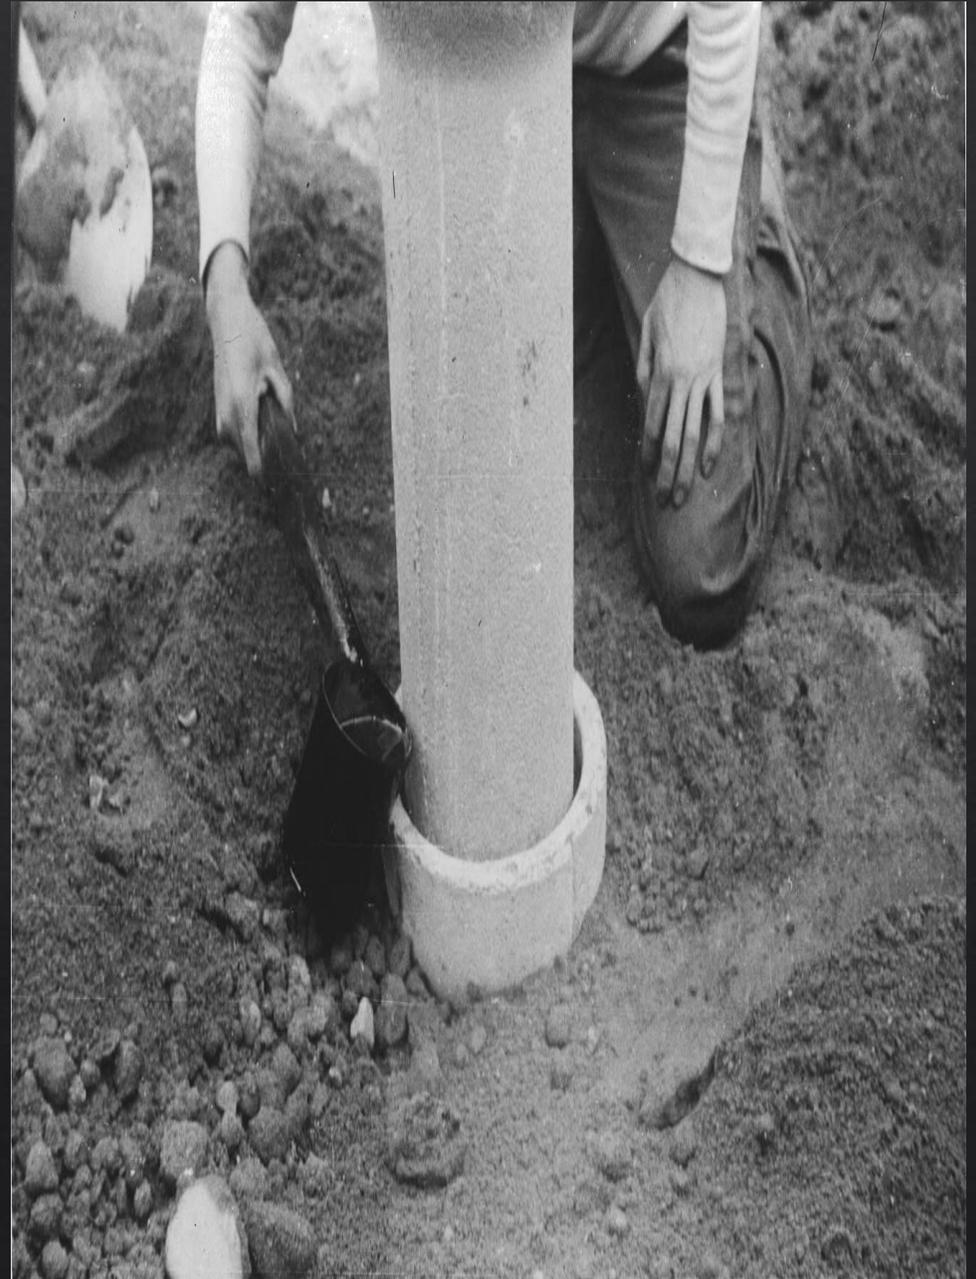
2/21/54

(Left) Workman tamping Okum into bell of riser joint below water table.

(Right) Workman pouring hot tar into the riser, joint over packed Okum.

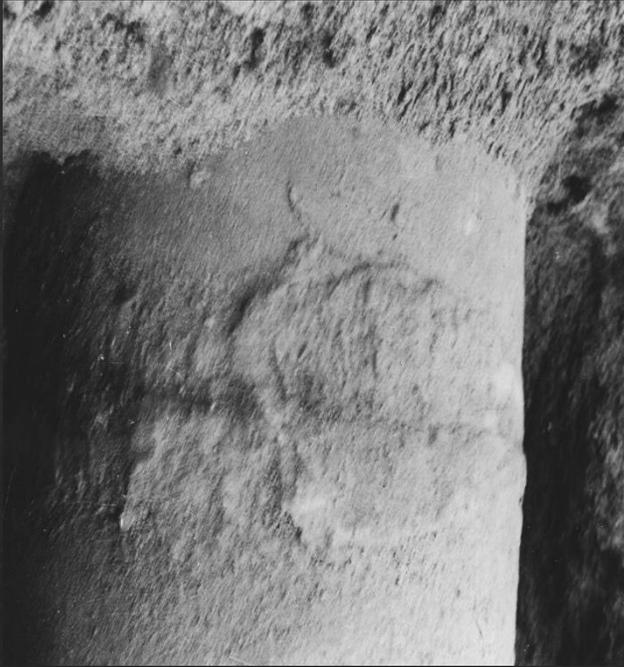
2/16/54

(Top) Discoloration of grout indicate a leaking connection in 18" line No. of Zickert Rd. This joint was cleaned and re-grouted. This was the only leaking concrete joint found by the City Inspector.

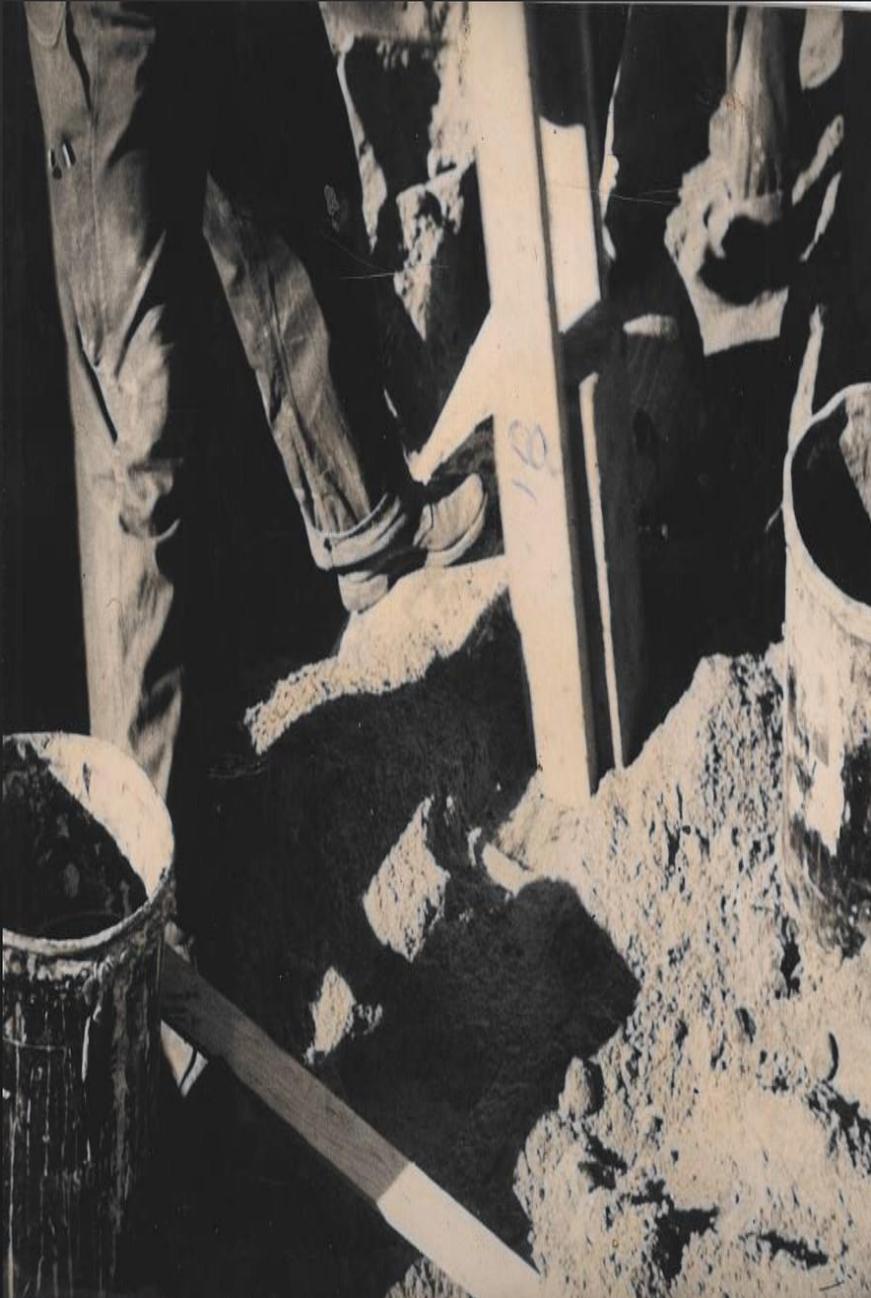
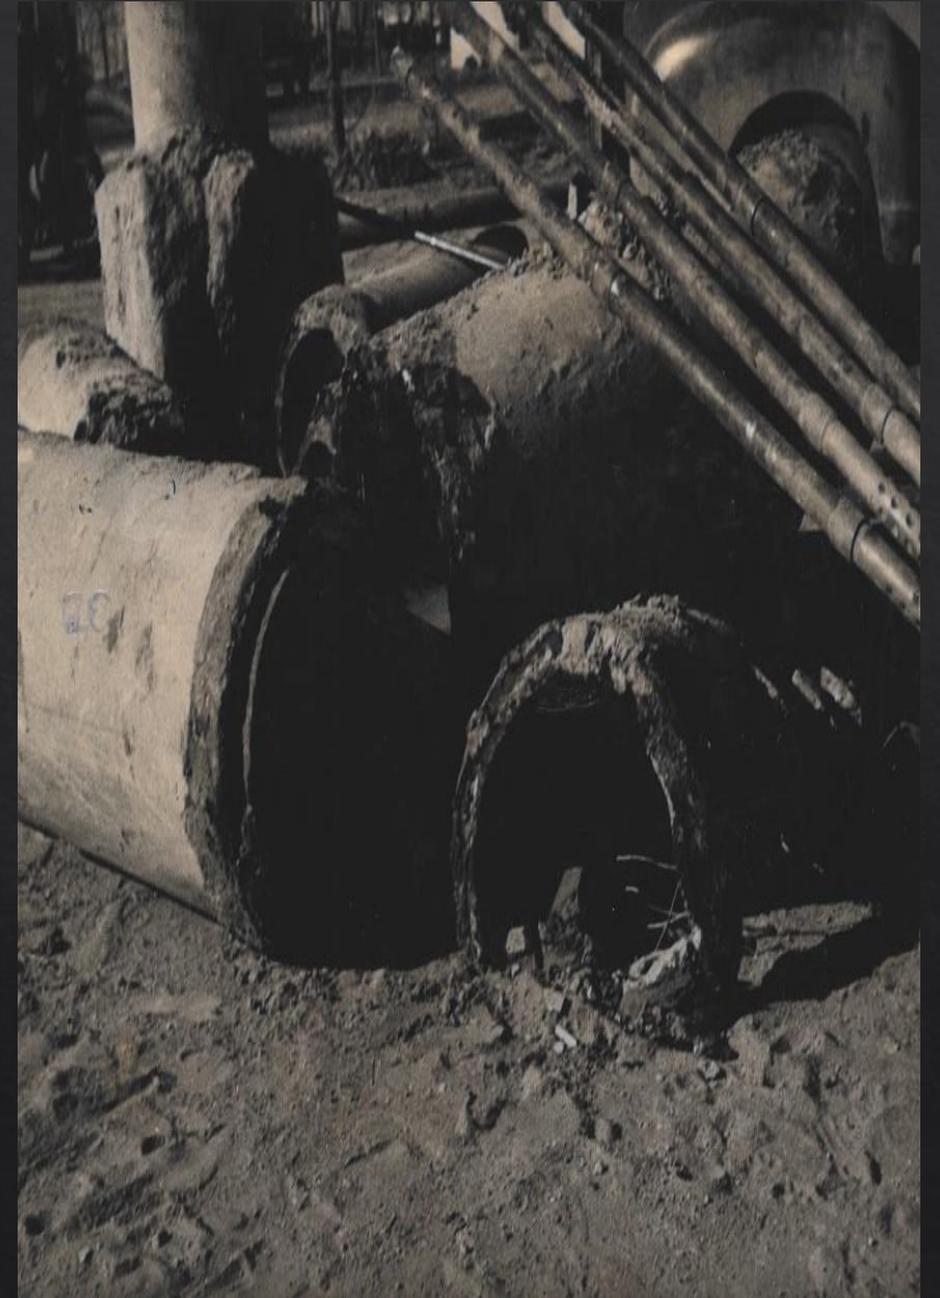
2/20/54

(Left) Tamping  
around trunk line  
near a riser.

(Right) Discarded  
Mastic line 15"  
Montoya line.

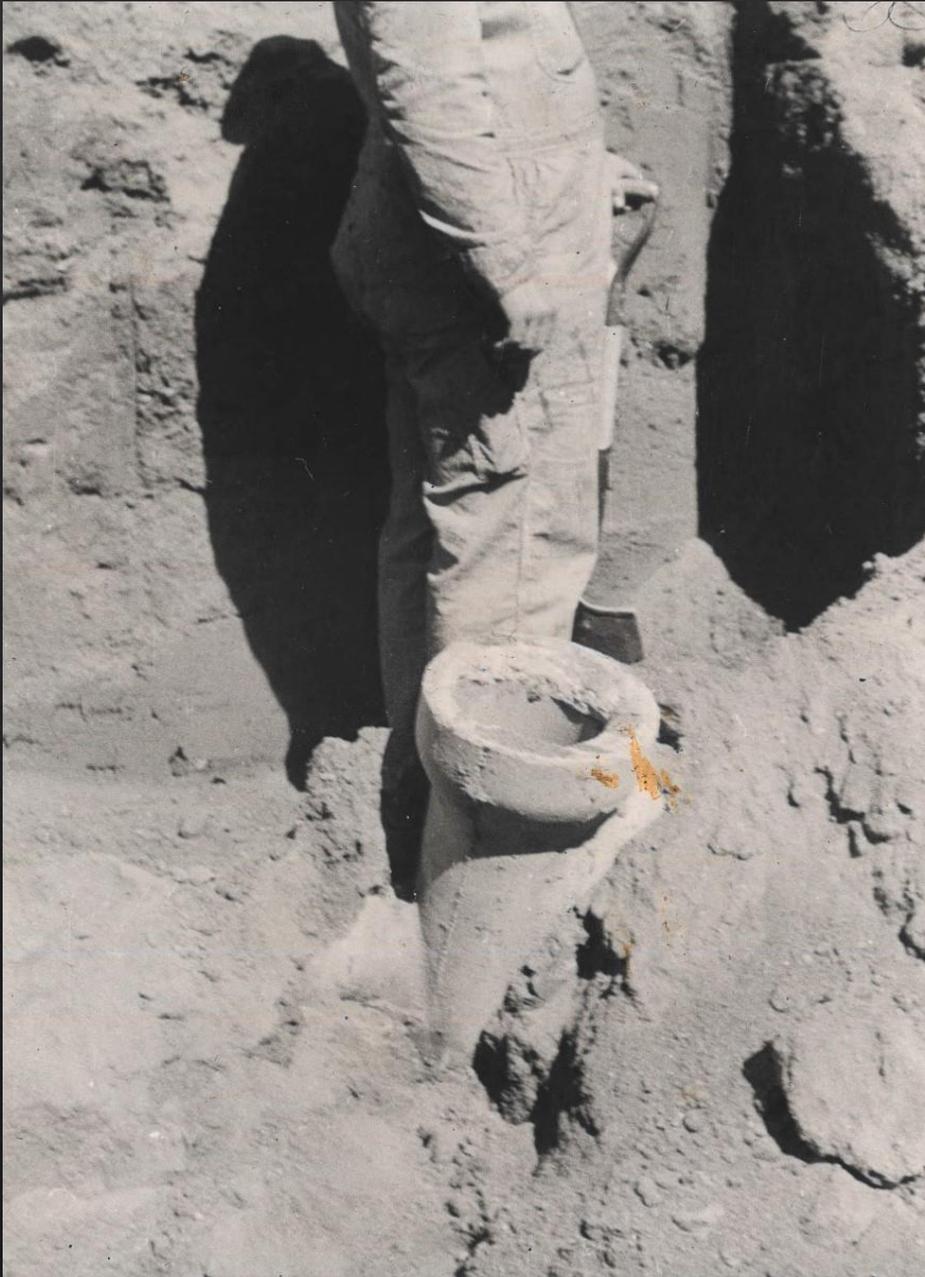
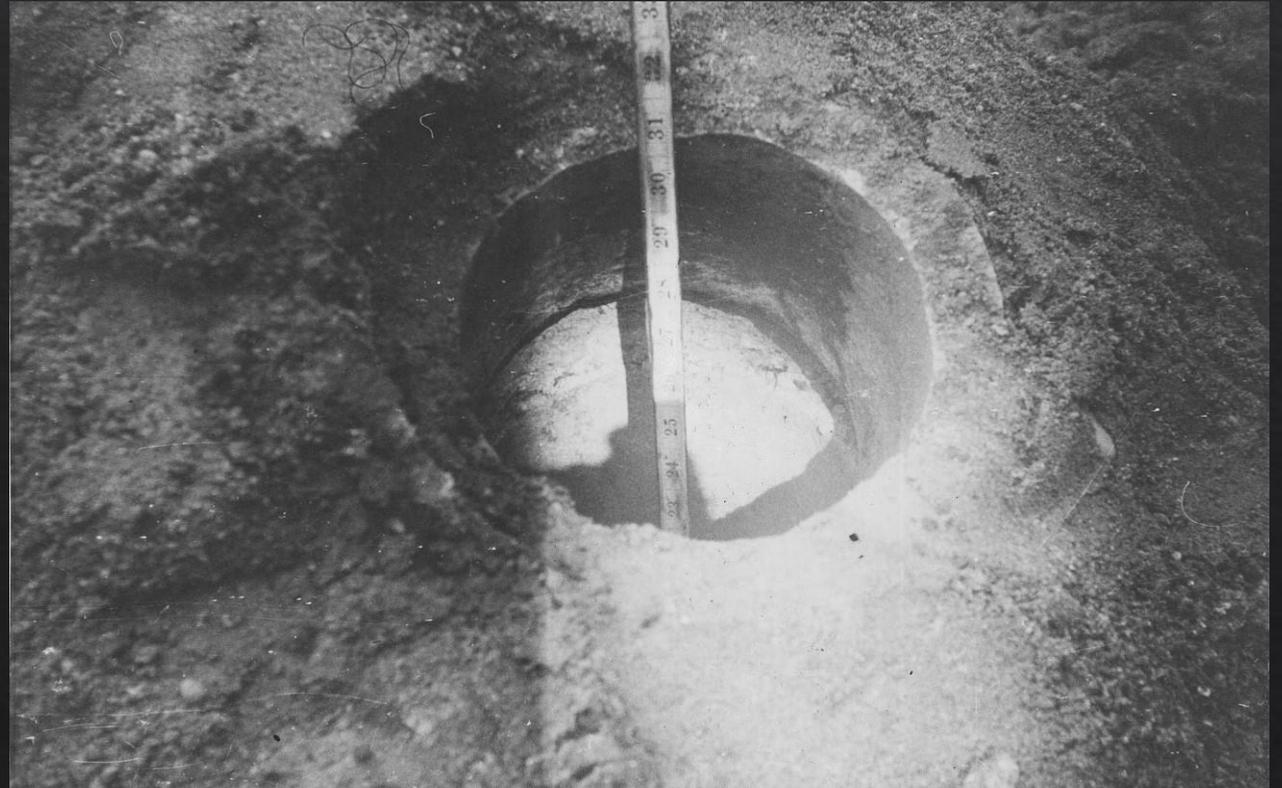
2/26/54

(Left) Riser Found 360' No. of Ortiz M.H. was only 2' below the street grade.

(Bottom) Riser 360' No. of Ortiz M.H. upper portion of the broken Y-joint has been removed.

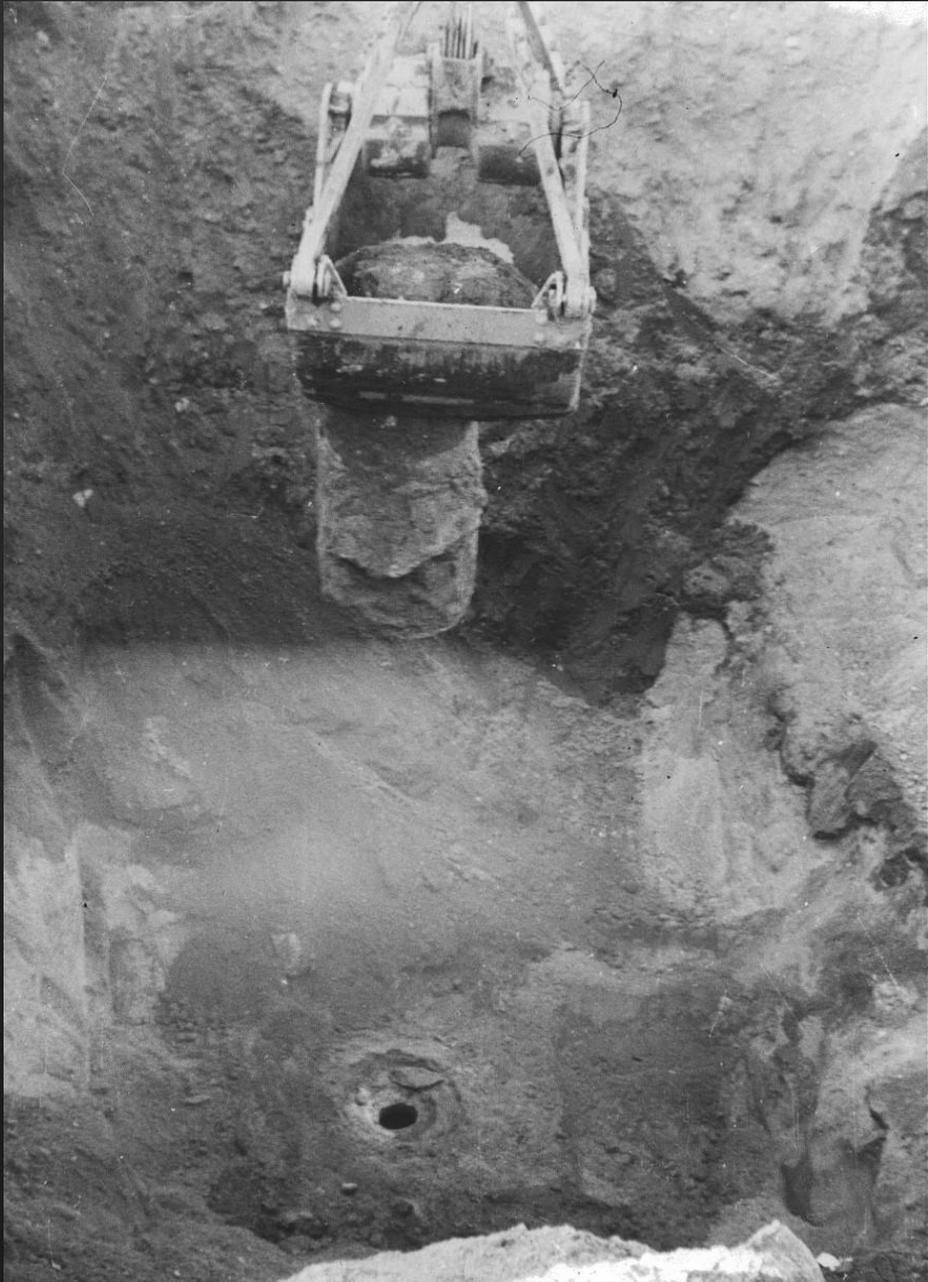
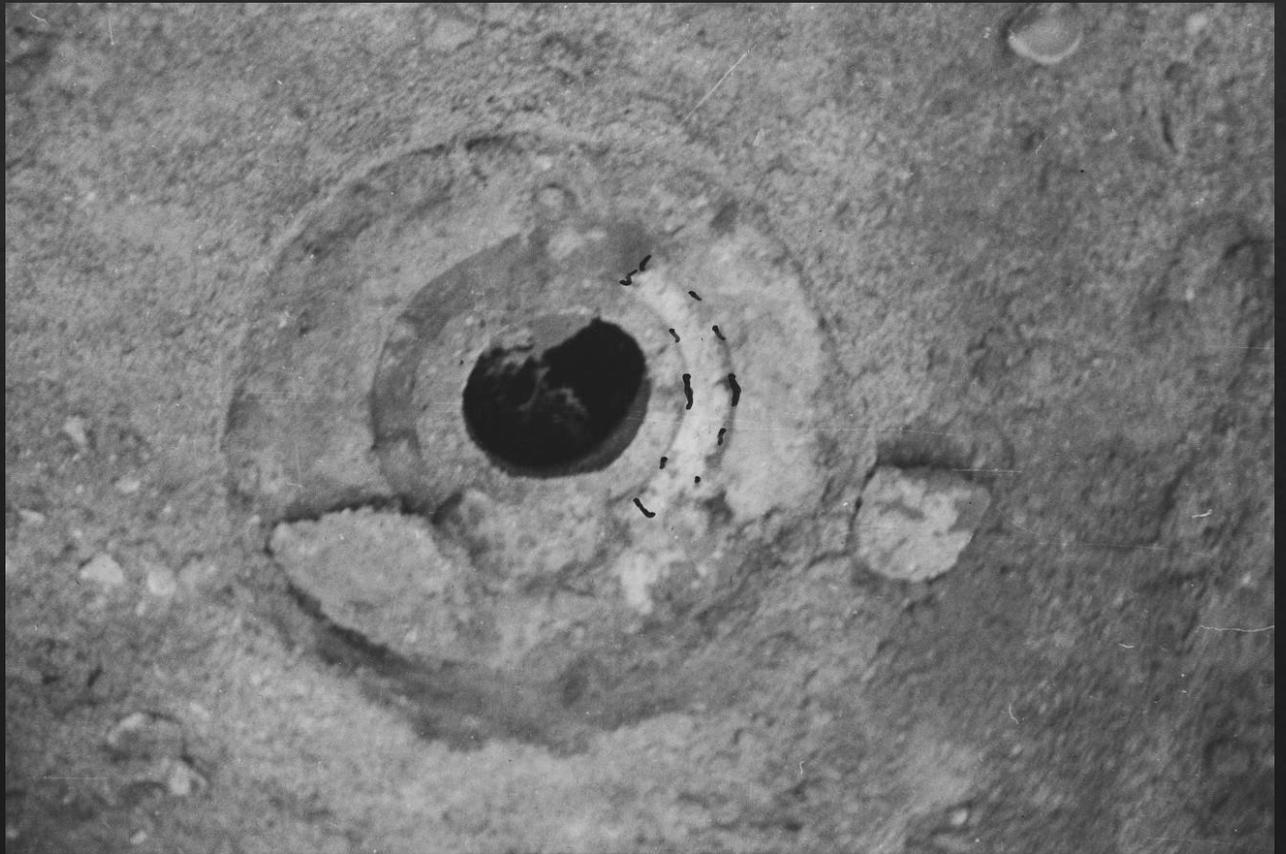
2/28/54

(Left) Riser 420' No. CF Ortiz M.H. Clam bucket lifting broken riser barrel from 18" line.  
(Bottom) Riser 420' No. of Ortiz M.H Close up of T, in the trunk line.

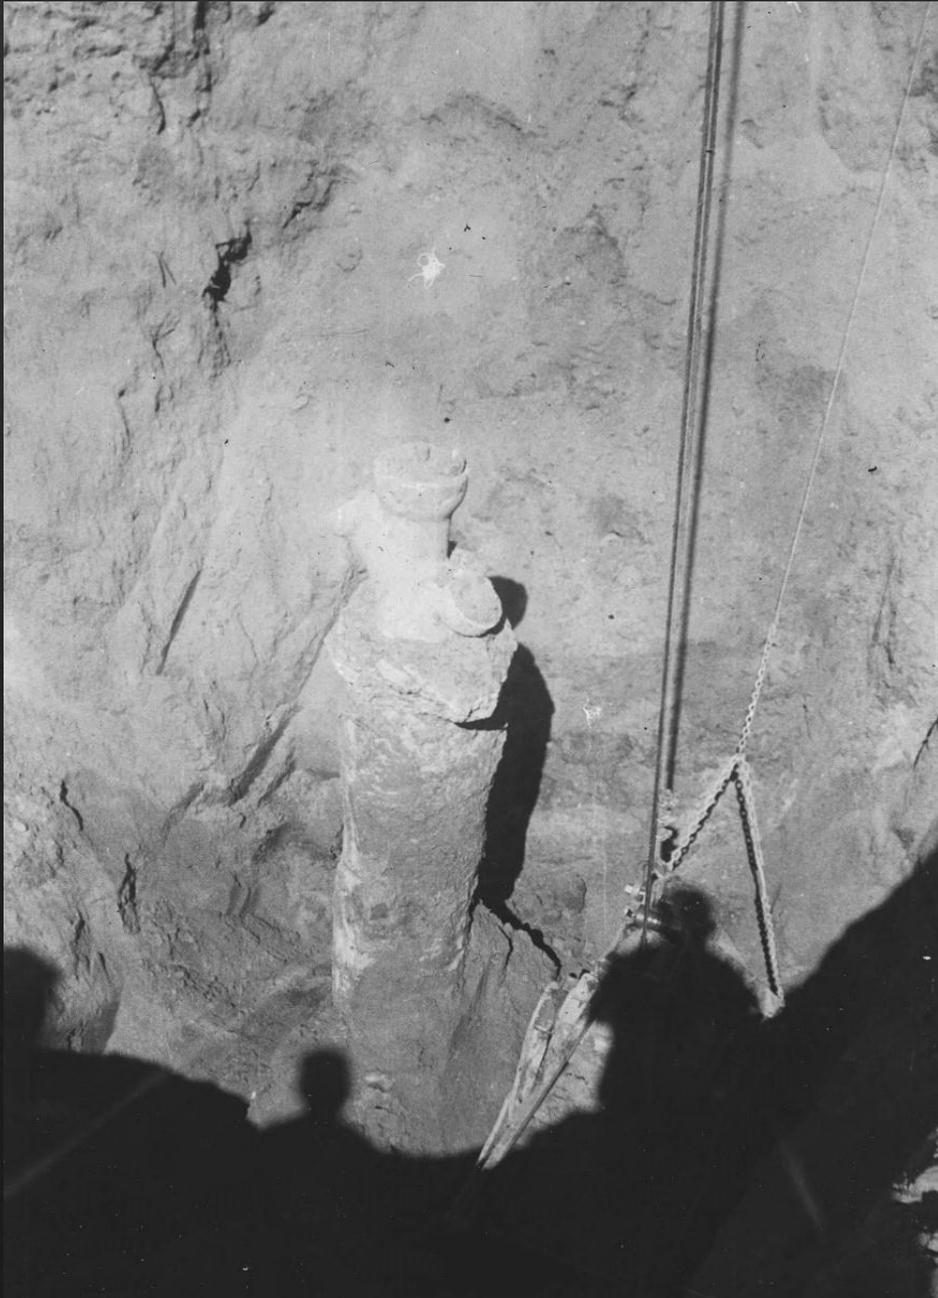
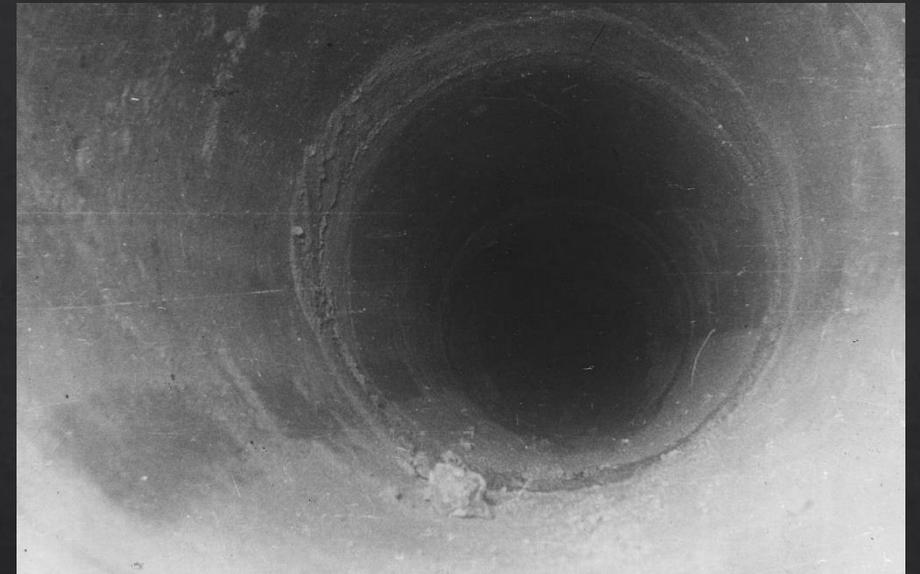
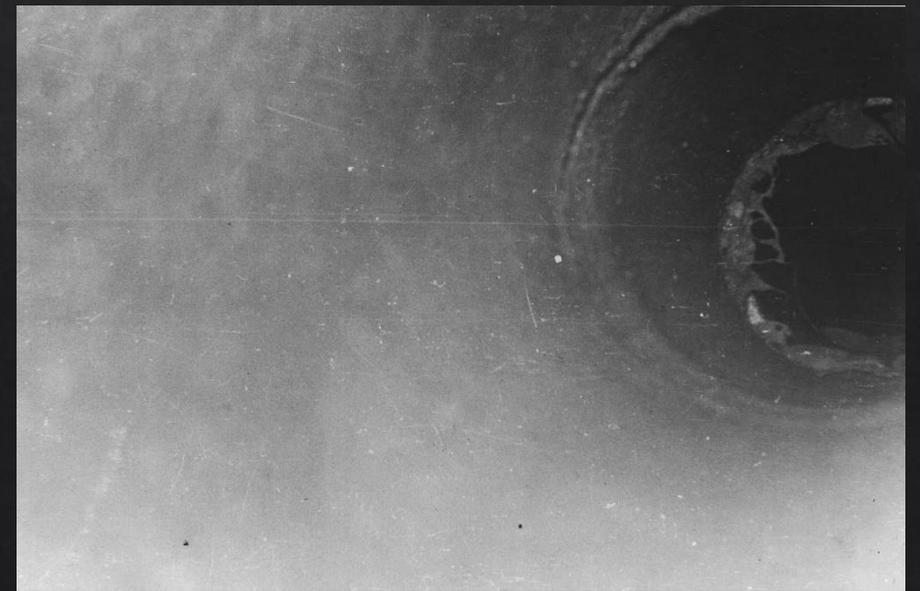
3/1/54

(Left) First riser removed from 460' No. of Ortiz M.H. in good condition.

(Top Right)  
Inside 18" line after removing mastic compound and re-grouting with cement.

(Bottom Right)  
Inside 8" Lateral line west from Rio Grande and Zickert M.H.

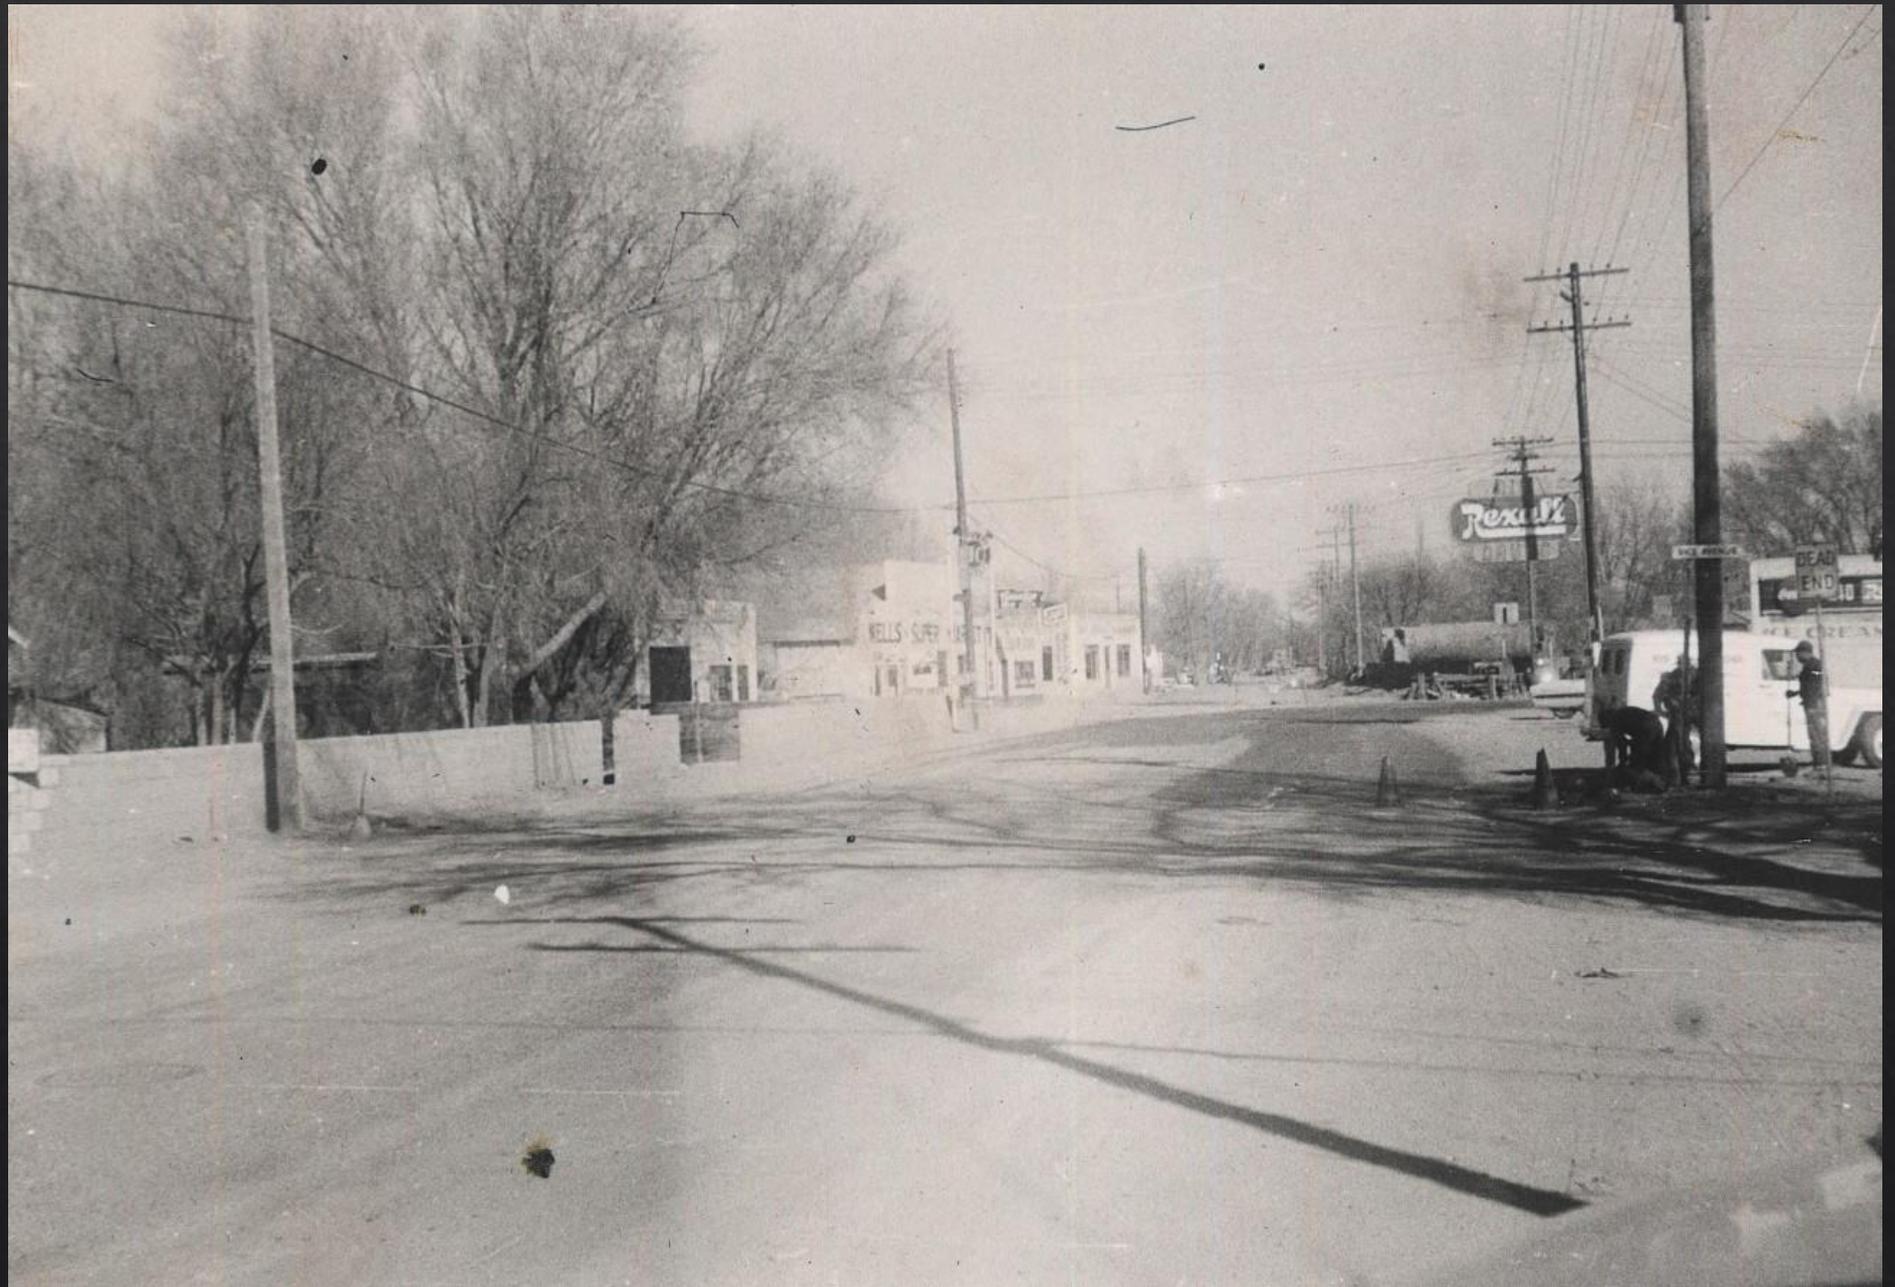
3/4/54

Rio Grande at  
Indian School Rd.  
Detour removed –  
water tank was  
used in testing.
