# CMOM Annual Report 2021

## **Capacity, Management, Operations and Maintenance (CMOM) Plan Overview**

In accordance with National Pollutant Discharge Elimination System (NPDES) Permit No. NM0022250 (Permit), the Albuquerque Bernalillo County Water Utility Authority (Water Authority) prepared this Capacity, Management, Operations and Maintenance (CMOM) Plan. The Permit was renewed in CY2019 with an effective date of December 1, 2019.

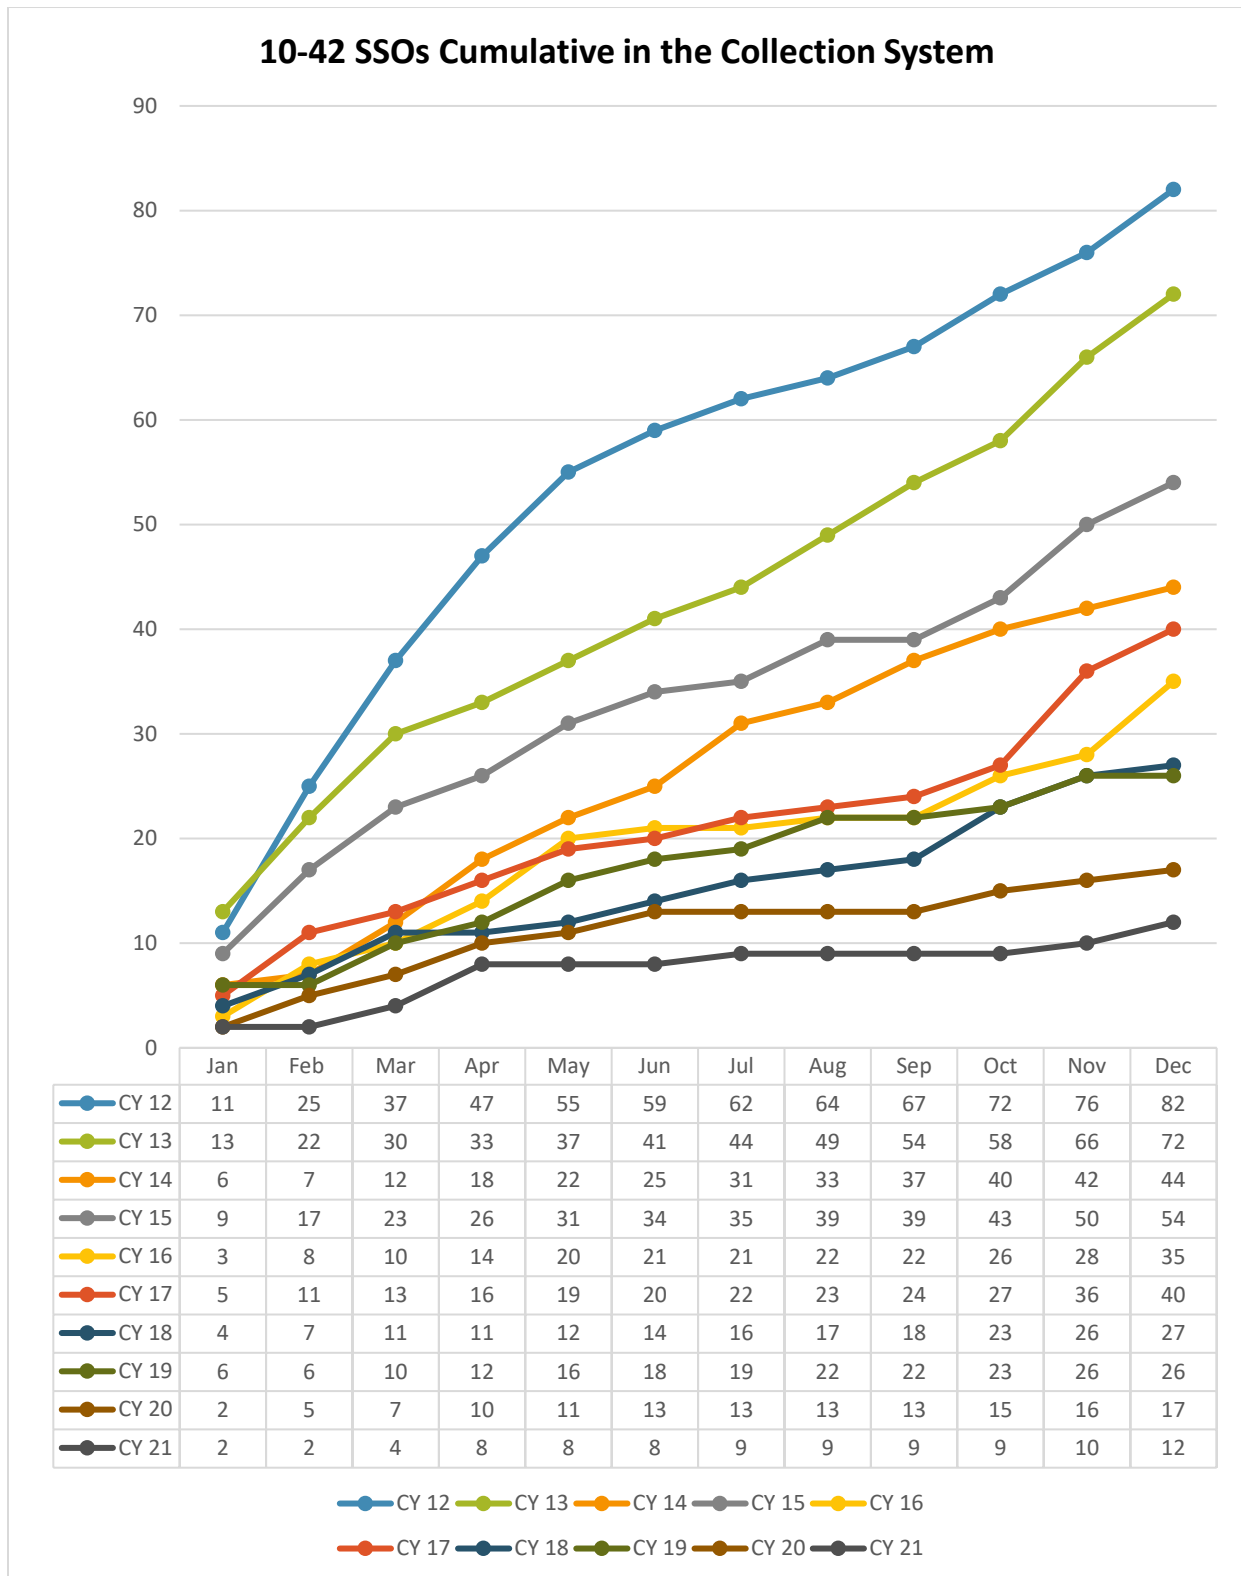
**Figure 1 Reportable SSOs**

Figure 1 shows the cumulative 10-42s by month for CY2012-21.

The SSO Rate is defined as 100 times the number of SSOs in a year divided by the miles of sewer in the system. The Water Authority system has a total of approximately 2,414 miles of line (p. 8 of the Self-Assessment). The SSO rate is therefore 3.4, 3.0, 1.8, 2.2, 1.4, 1.7, 1.1, 1.1, 0.7 and 0.5 for CY2012-21 respectively.

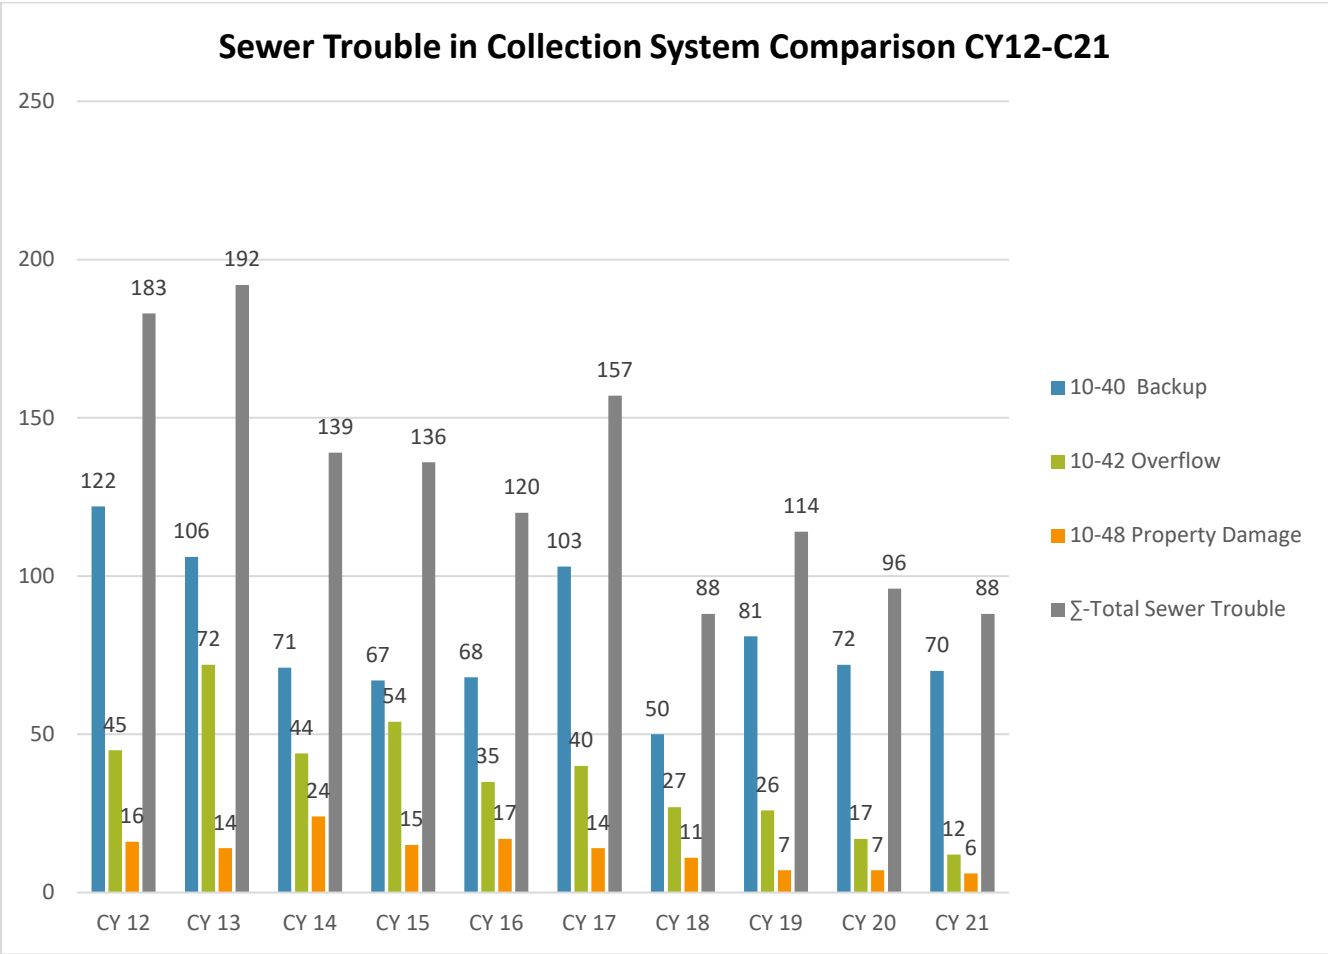
**Figure 2 Sewer Trouble Comparison**

Figure 2 shows the total sewer troubles, i.e. 10-40s, -42s, and -48s by year for CY2012-21. This graph does not include 10-48s due to “burps” which are not due to a blockage or other failure resulting in the overflow of sewage. Instead, air displaced during the Vactor jetting cleaning can under certain circumstances force out the water in the home fixture P-traps, e.g. toilets and sinks. These sometimes result in claims and are therefore included in the Property Damage totals for completeness and consistency. There were only two burps during CY 2021. These burps are identified in Appendix 1.

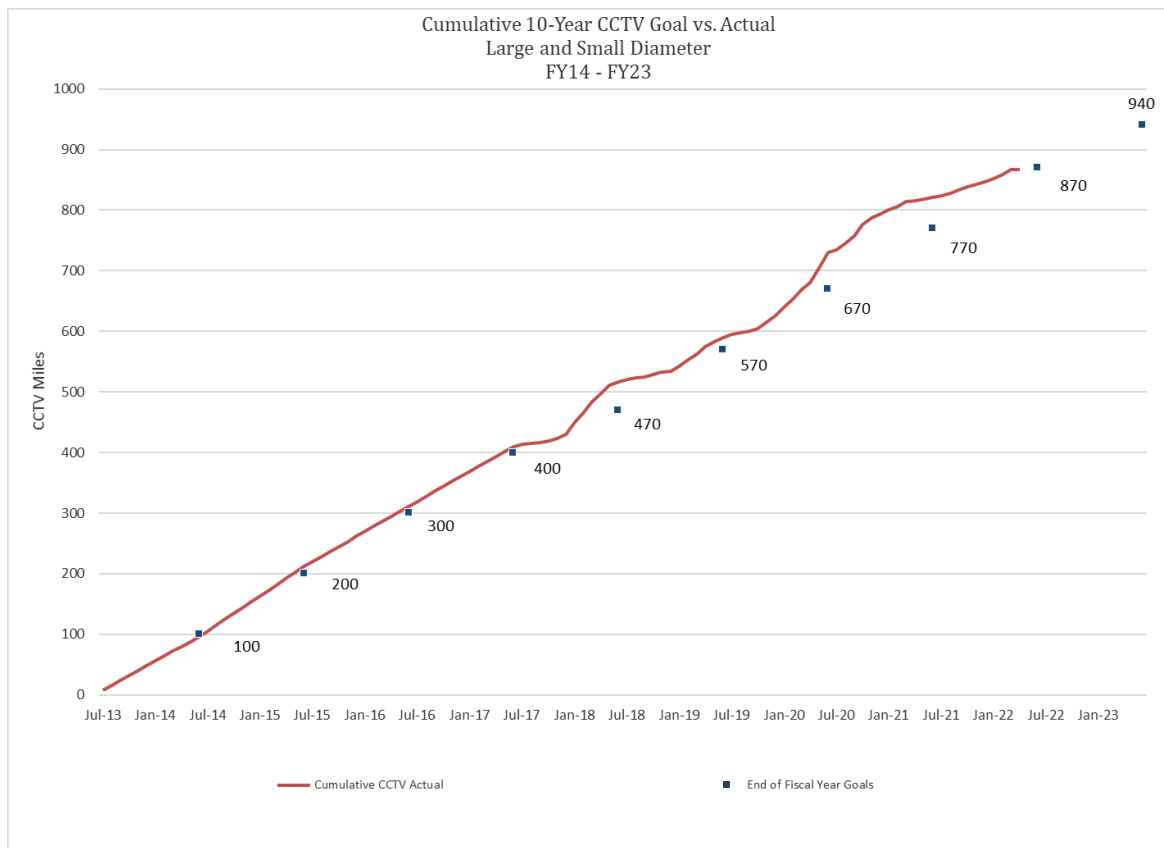
**Figure 3 Small Diameter Sewer CCTVed vs. Ten-Year Goal**

This is an on-going program. The following recommendation is made in the FY2013 CMOM Report: “CCTV inspections of the collection system as follows: 1) Small diameter main lines less than 15”: In four of five years, televise approximately 5% per year of the small diameter system. Televise high risk lines based on current Asset Management Plan and subsequent in-house analysis. 2) Large diameter lines 15” and larger: Every fifth year, televise as much as possible acknowledging access limitations of the unlined concrete lines 15” and larger. Anticipated schedule: 3) FY2014-17: 5% of the small diameter each year. 2) FY18: Large diameter unlined concrete pipe.”

CMOM Report figures for cleaning and CCTV will continue showing fiscal year (FY) goals in accordance with funding and contracting cycles and actual metrics will reflect work through the end of the calendar year (CY). Figure 3 provides the CCTV goal for a ten-year basis and the actual CCTV inspection through CY2021. The CY2021 portion of this recommendation is complete. The CCTV program will continue. Anticipated schedule:

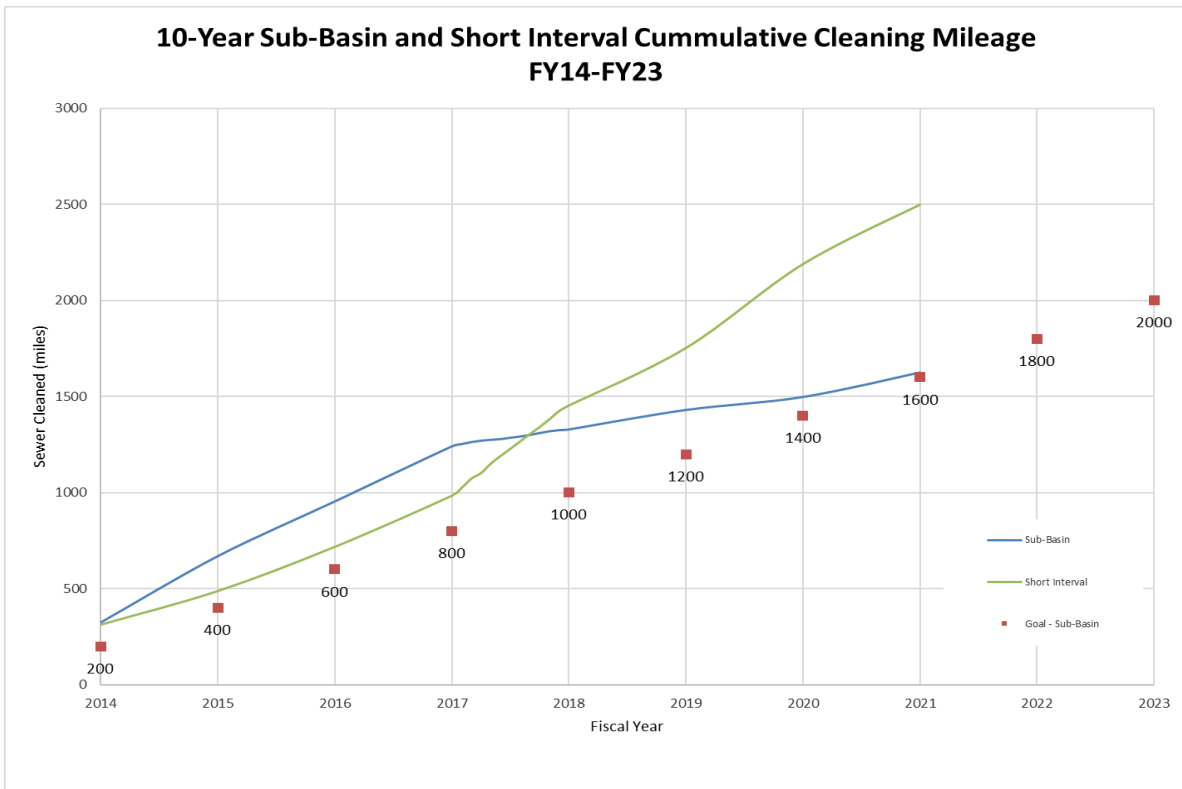
**Figure 4 Small Diameter Sewer Cleaned vs. Ten-Year Goal**

This is an on-going program. The following recommendation is made in the FY2013 CMOM Report: “The Water Authority will establish and monitor a goal of cleaning all gravity small diameter lines every ten years. (This will be accomplished through the existing Sub-Basin program.) The Water Authority will continue the program of high-frequency maintenance of known problem locations within the system. (This will be accomplished through the existing Short Interval program.) The frequency of Short Interval cleaning will vary in accordance with system performance and risk factors, maintenance history, and the latest maintenance findings.”

CMOM Report figures for cleaning and CCTV will continue showing fiscal year (FY) goals in accordance with funding and contracting cycles and actual metrics will reflect work through the end of the calendar year (CY). As shown Figure 4, the Water Authority is ahead of its goal to clean then entire system once in ten years through the Sub-Basin program.
