CMOM ANNUAL REPORT CY2017

Capacity, Management, Operations and Maintenance (CMOM) Plan Overview

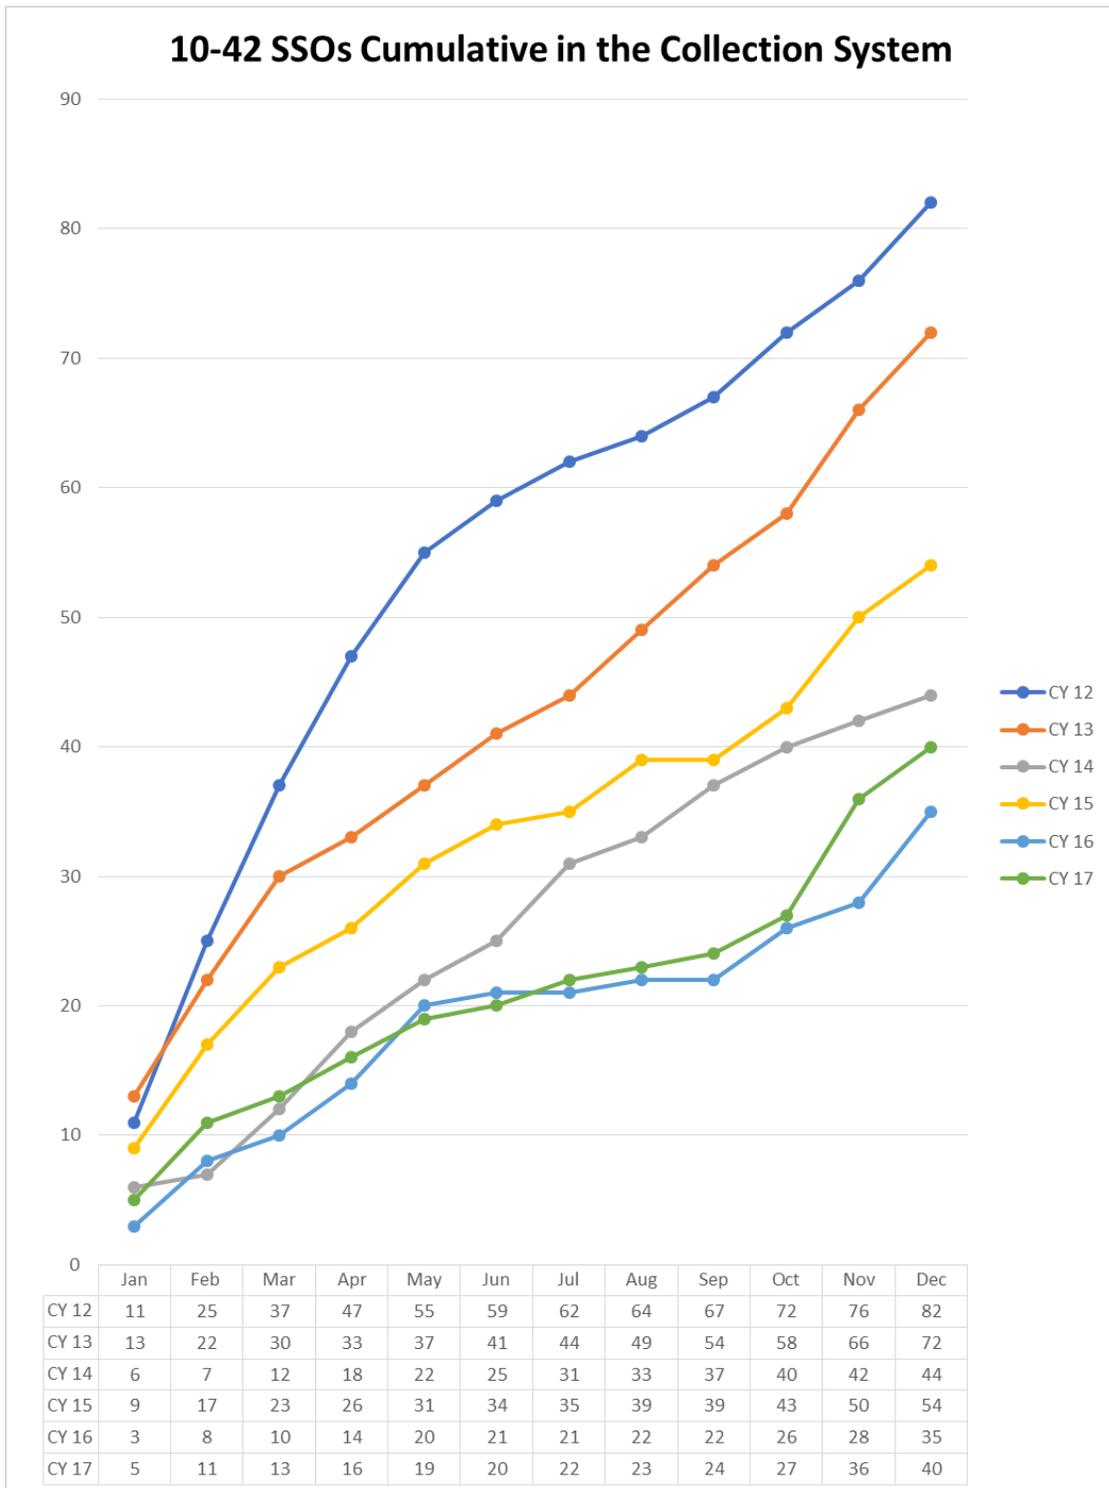
Figure 1 Reportable SSOs

Figure 1 shows the cumulative 10-42s by month for CY2012-17.

The SSO Rate is defined as 100 times the number of SSOs in a year divided by the miles of sewer in the system. The Water Authority system has a total of approximately 2,414 miles of line (p. 8 of the Self-Assessment). The SSO rate is therefore 3.4, 3.0, 1.8, 2.2, 1.4, and 1.7 for CY2012-17 respectively.

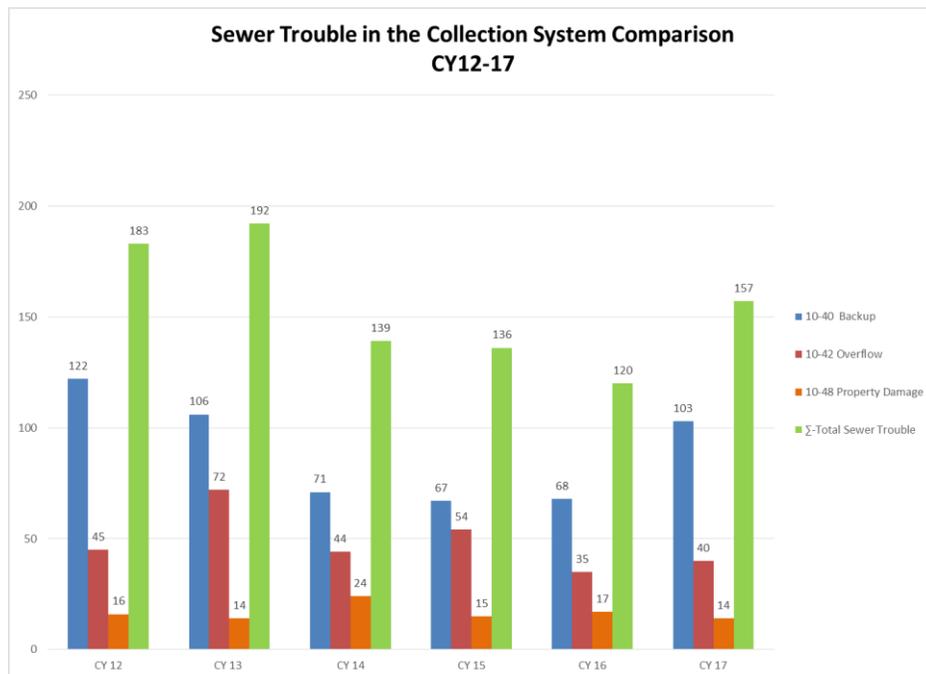
Figure 2 Sewer Trouble Comparison

Figure 2 shows the total sewer troubles, i.e. 10-40s, -42s, and -48s by year for CY2012-17. This graph does not include 10-48s due to “burps” which are not due to a blockage or other failure resulting in the overflow of sewage. Instead, air displaced during the Vactor jetting cleaning can under certain circumstances force out the water in the home fixture P-traps, e.g. toilets and sinks. These sometimes result in claims and are therefore included in the Property Damage totals for completeness and consistency. There were two burps during the July 1, 2017 through December 31, 2017 timeframe. These burps are identified in Appendix 1.

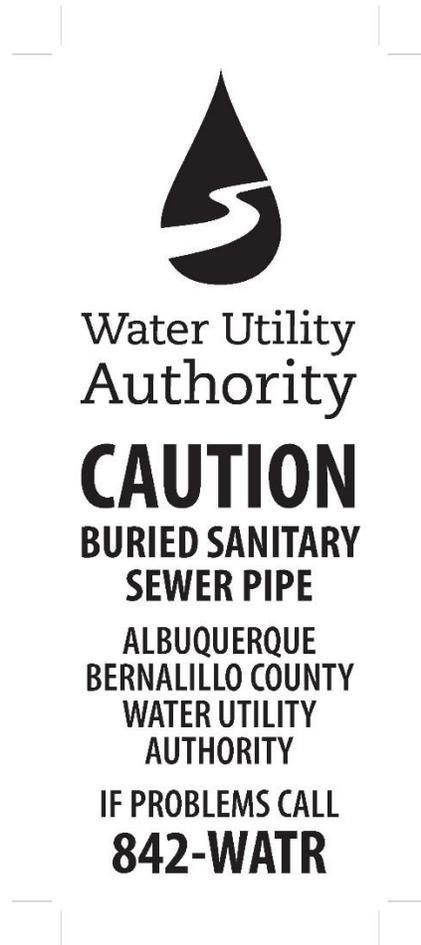
Figure 4 New Decals for Marker Posts

In CY2017, the Water Authority developed new marker decals, see below, to place on marker posts. These posts will be placed during the next round of force main inspections. Call before you dig decals obtained from NM811 are also to be placed on the posts.

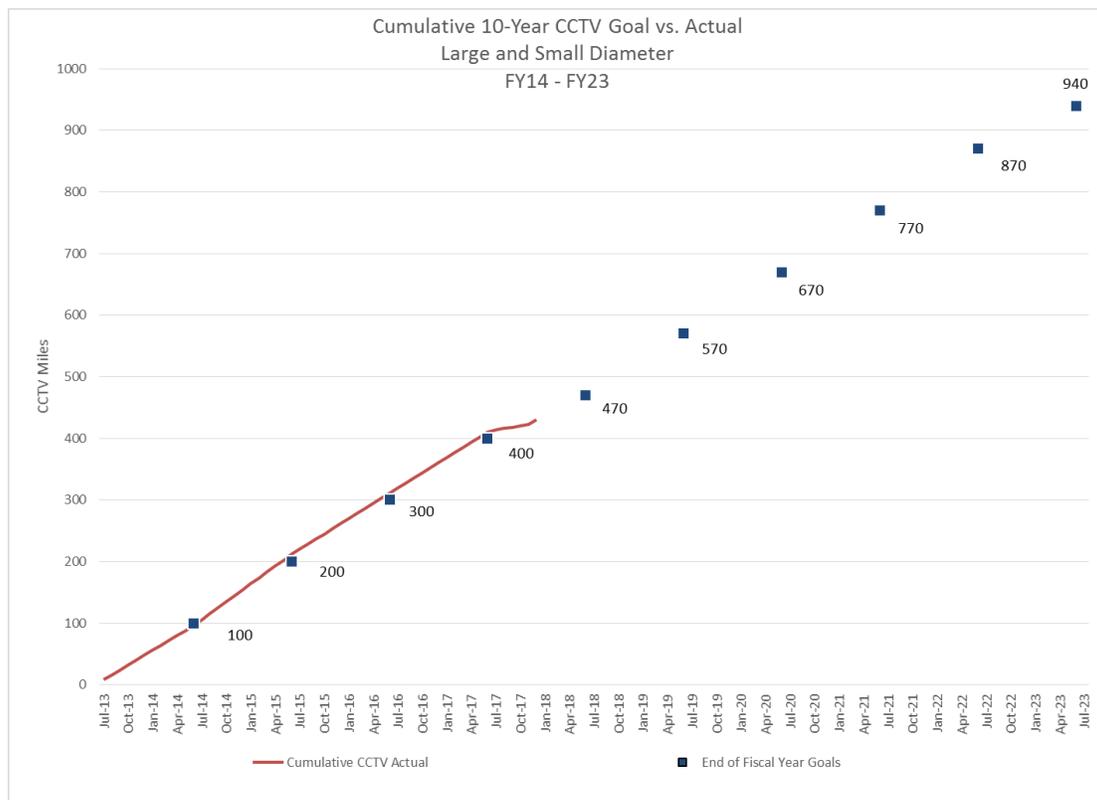
Figure 5 Small Diameter Sewer CCTVed vs. Ten-Year Goal

CMOM Report figures for cleaning and CCTV will continue showing fiscal year (FY) goals in accordance with funding and contracting cycles and actual metrics will reflect work through the end of the calendar year (CY). Figure 5 provides the CCTV goal for a ten-year basis and the actual CCTV inspection for the first four years. The FY2017 portion of this recommendation is complete.

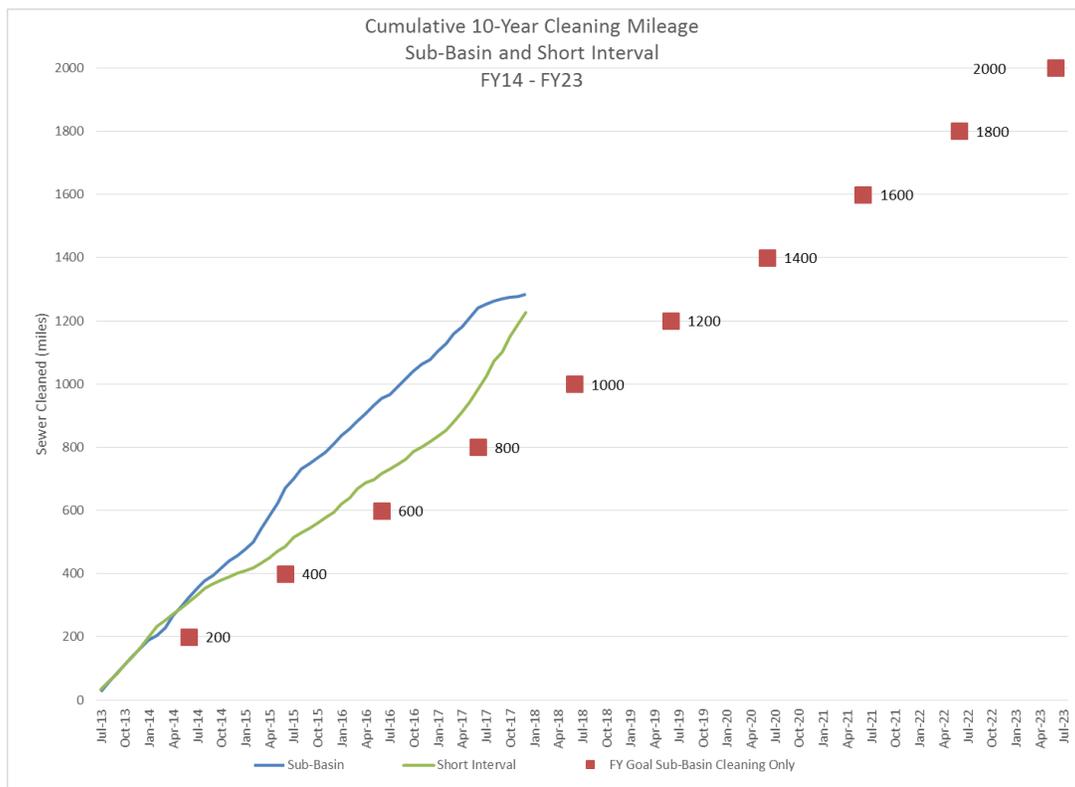
Figure 6 Small Diameter Sewer Cleaned vs. Ten-Year Goal

CMOM Report figures for cleaning and CCTV will continue showing fiscal year (FY) goals in accordance with funding and contracting cycles and actual metrics will reflect work through the end of the calendar year (CY). As shown Figure 6, the Water Authority is ahead of its goal to clean then entire system once in ten years through the Sub-Basin program.

The Sub-Basin program and associated ten-year cleaning goal remain in place. While meeting this CMOM commitment for Sub-Basin cleaning, the Collection Section has increased Short Interval cleaning.

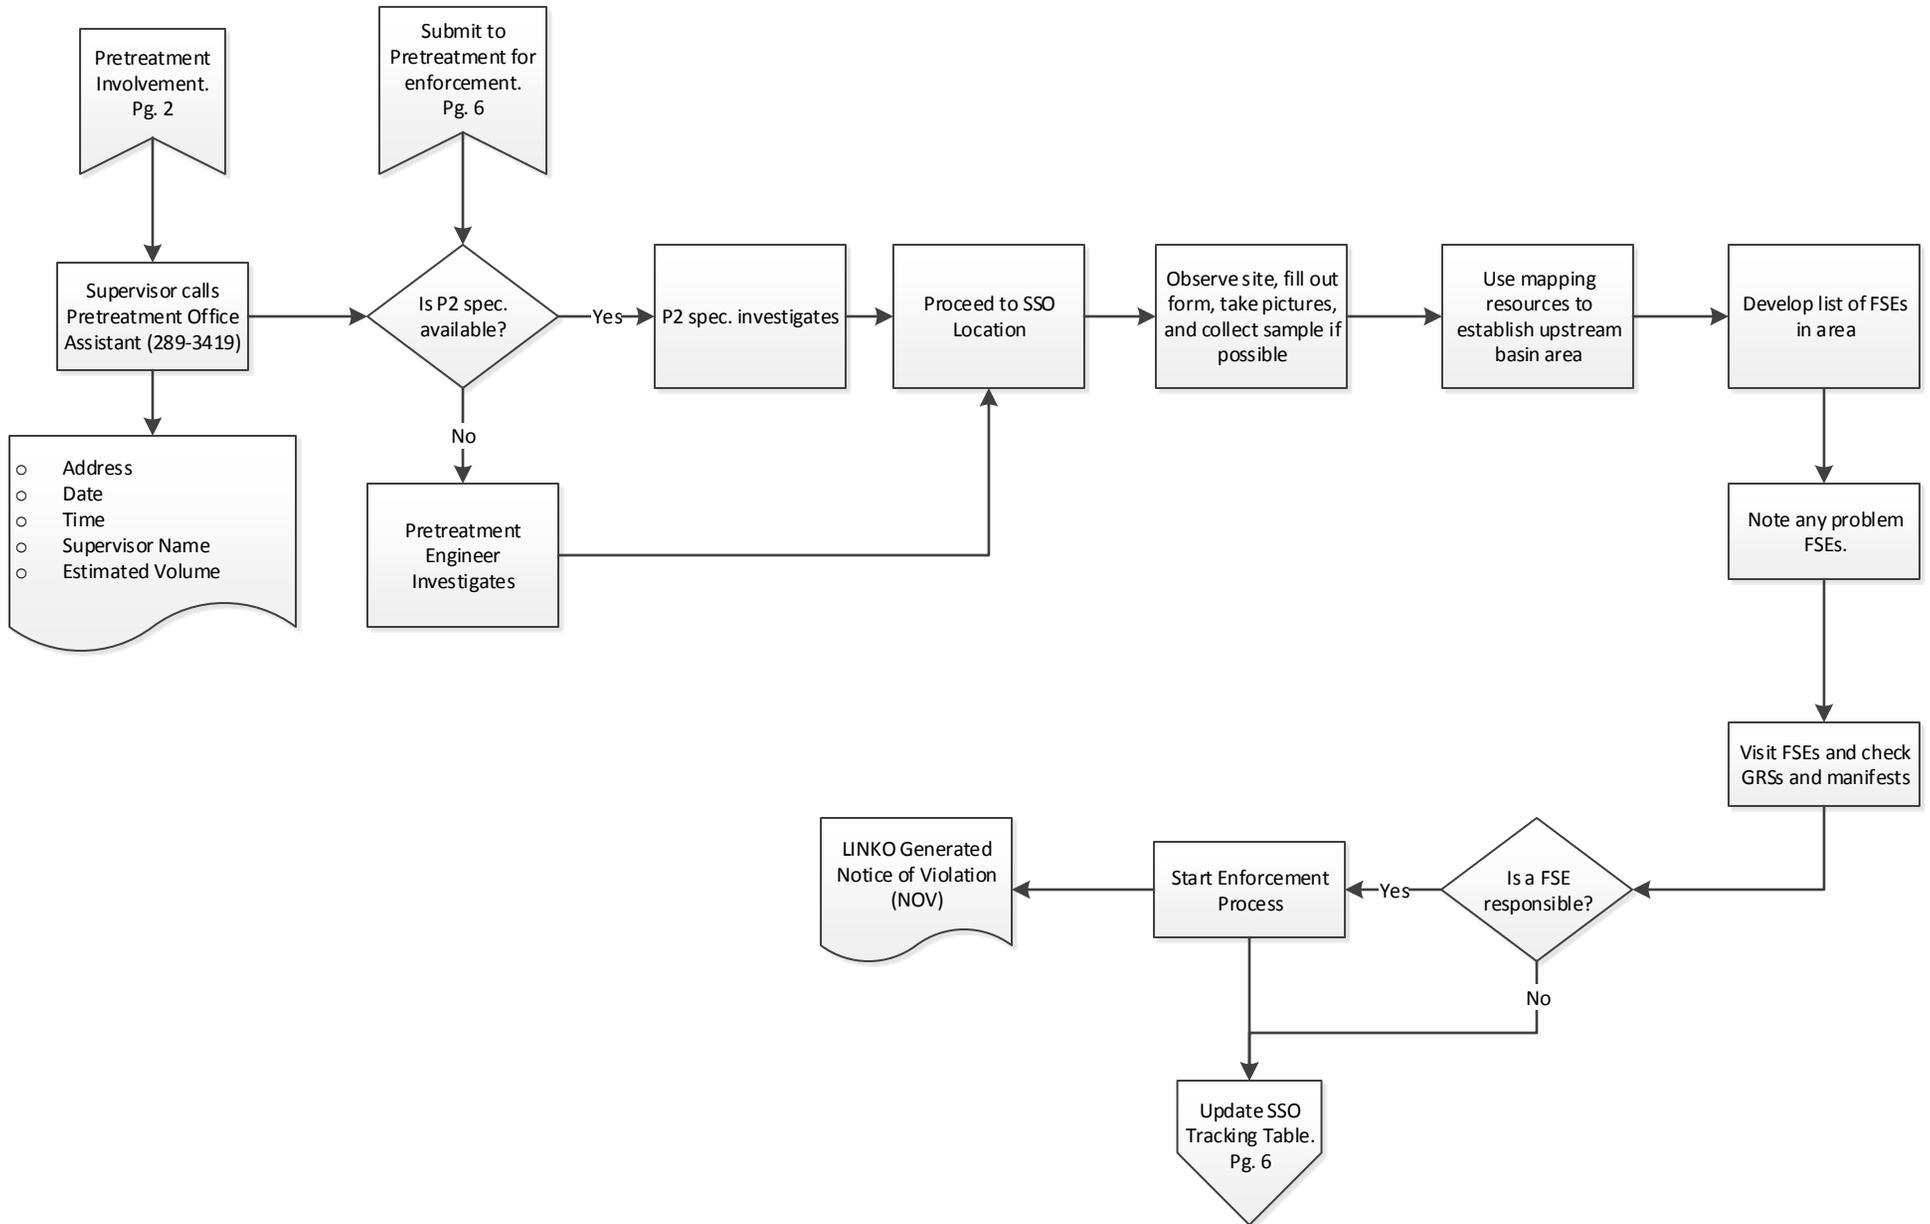
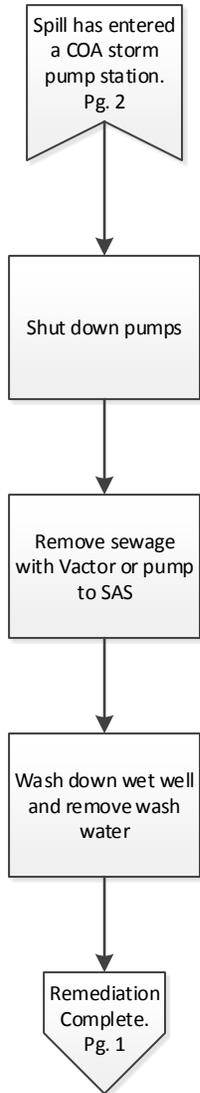
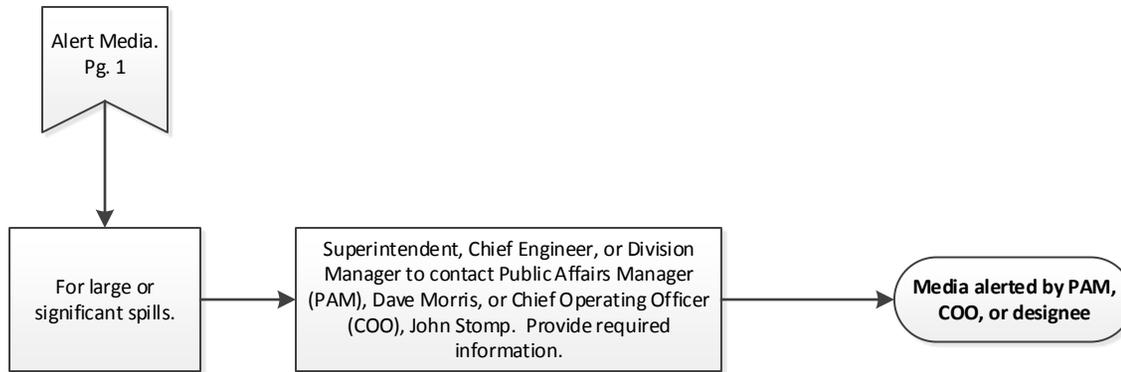
Note: Process shown is for typical spills. Some spills may require a joint response with the City of Albuquerque in which the spill is captured, treated, and determined appropriate for release.
