# CMOM ANNUAL REPORT CY2019

## **Capacity, Management, Operations and Maintenance (CMOM) Plan Overview**

In accordance with National Pollutant Discharge Elimination System (NPDES) Permit No. NM0022250 (Permit), the Albuquerque Bernalillo County Water Utility Authority (Water Authority) prepared this Capacity, Management, Operations and Maintenance (CMOM) Plan. The Permit was renewed in CY2019 with an effective date of December 1, 2019.

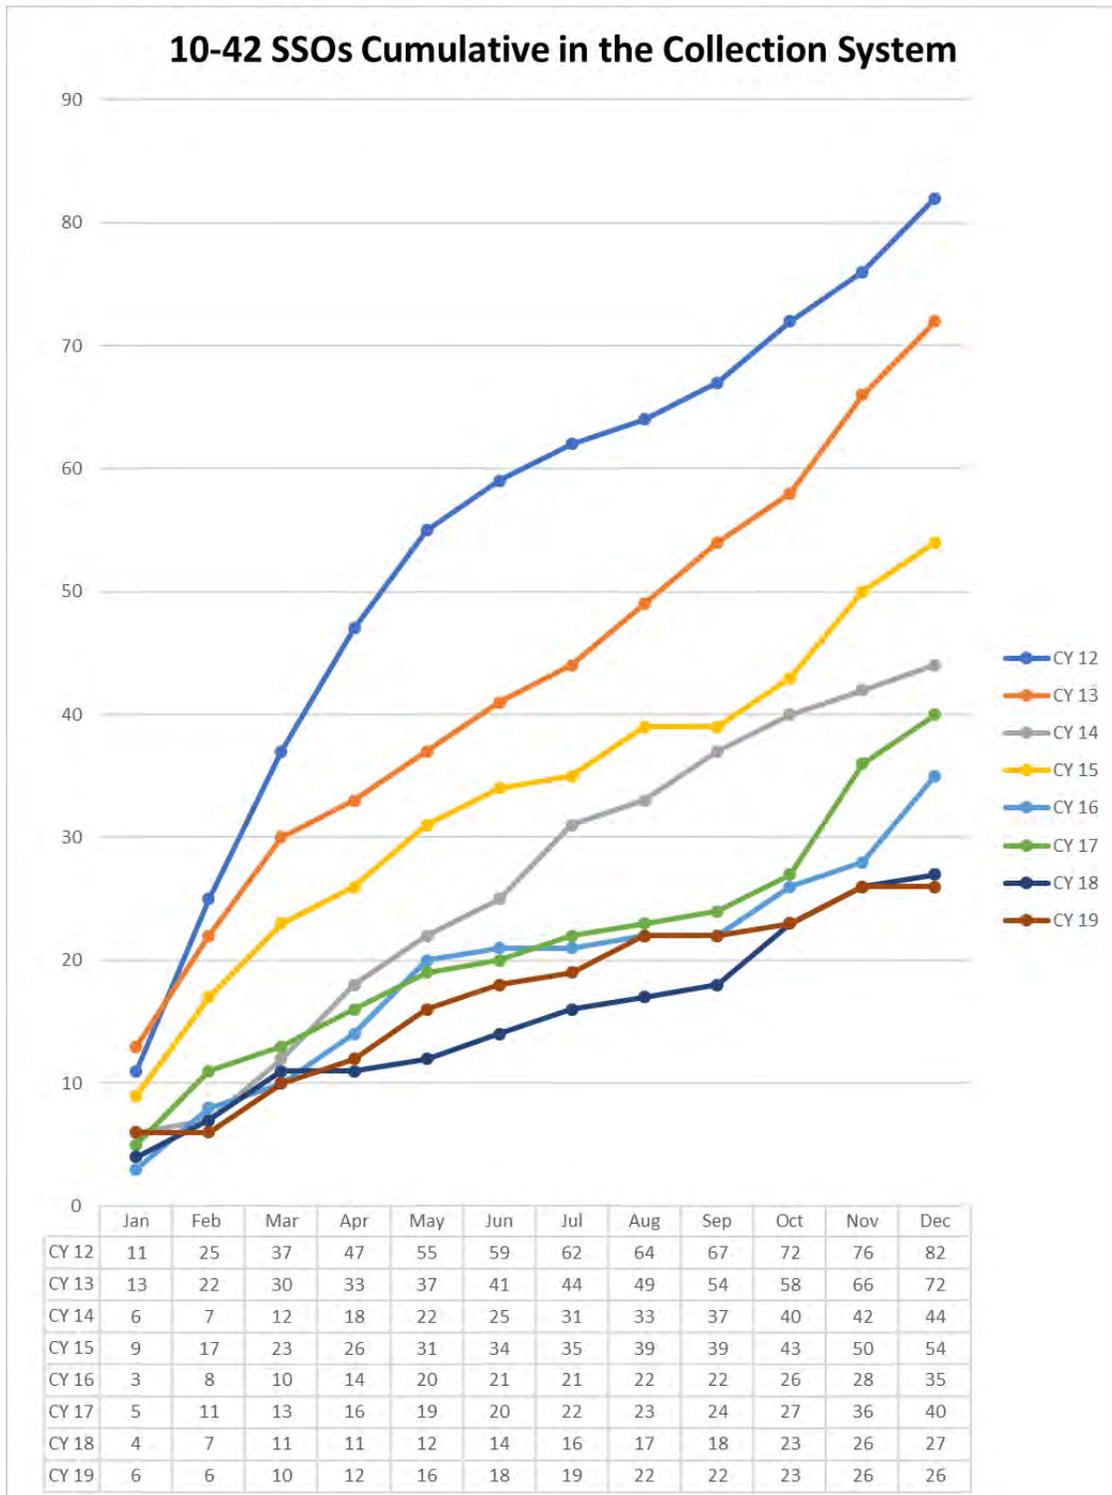
**Figure 1 Reportable SSOs**

Figure 1 shows the cumulative 10-42s by month for CY2012-18.

The SSO Rate is defined as 100 times the number of SSOs in a year divided by the miles of sewer in the system. The Water Authority system has a total of approximately 2,414 miles of line (p. 8 of the Self-Assessment). The SSO rate is therefore 3.4, 3.0, 1.8, 2.2, 1.4, 1.7, 1.1 and 1.1 for CY2012-19 respectively.

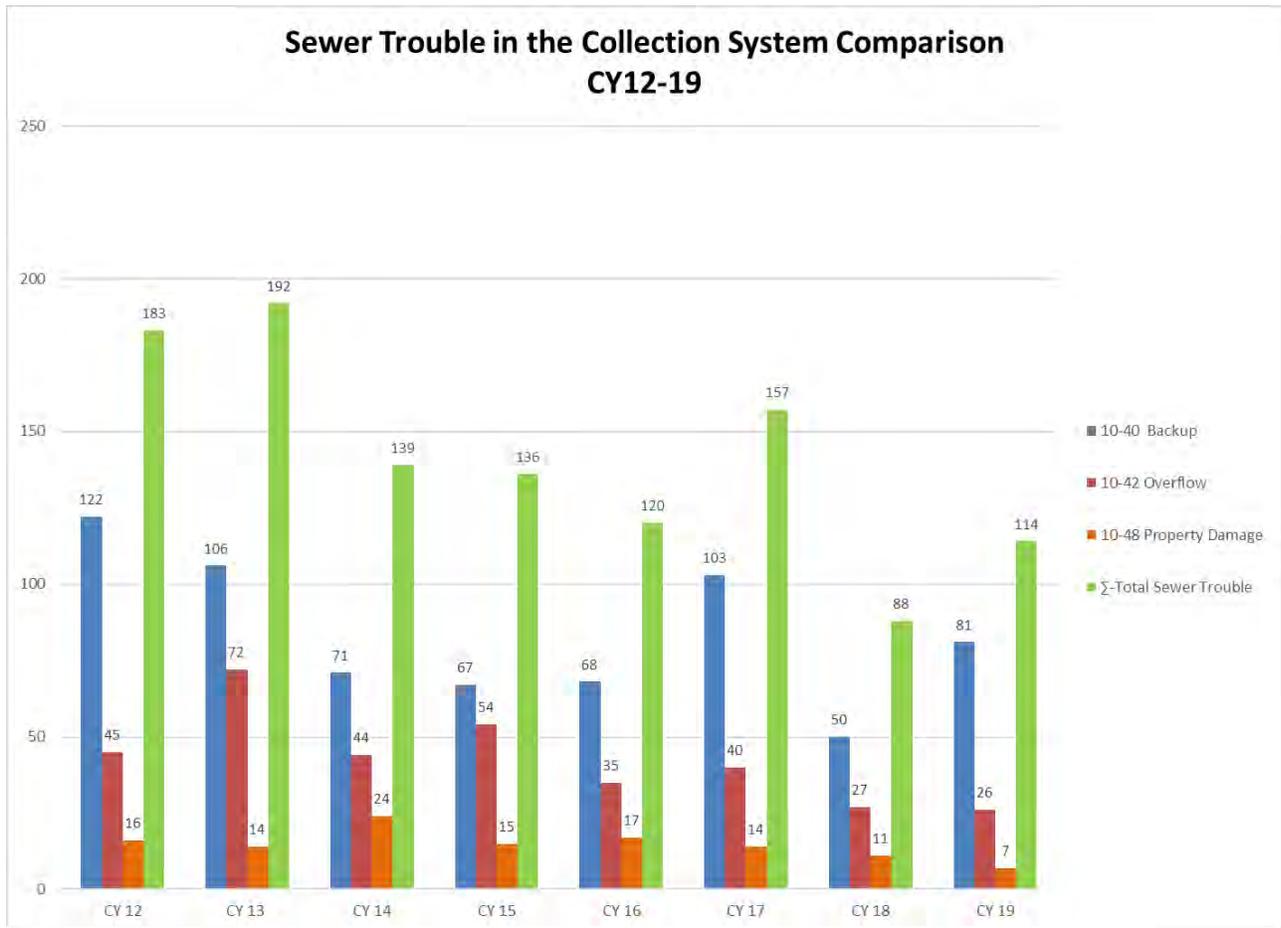
**Figure 2 Sewer Trouble Comparison**

Figure 2 shows the total sewer troubles, i.e. 10-40s, -42s, and -48s by year for CY2012-19. This graph does not include 10-48s due to “burps” which are not due to a blockage or other failure resulting in the overflow of sewage. Instead, air displaced during the Vactor jetting cleaning can under certain circumstances force out the water in the home fixture P-traps, e.g. toilets and sinks. These sometimes result in claims and are therefore included in the Property Damage totals for completeness and consistency. There were three burps during CY 2019. These burps are identified in Appendix 1.

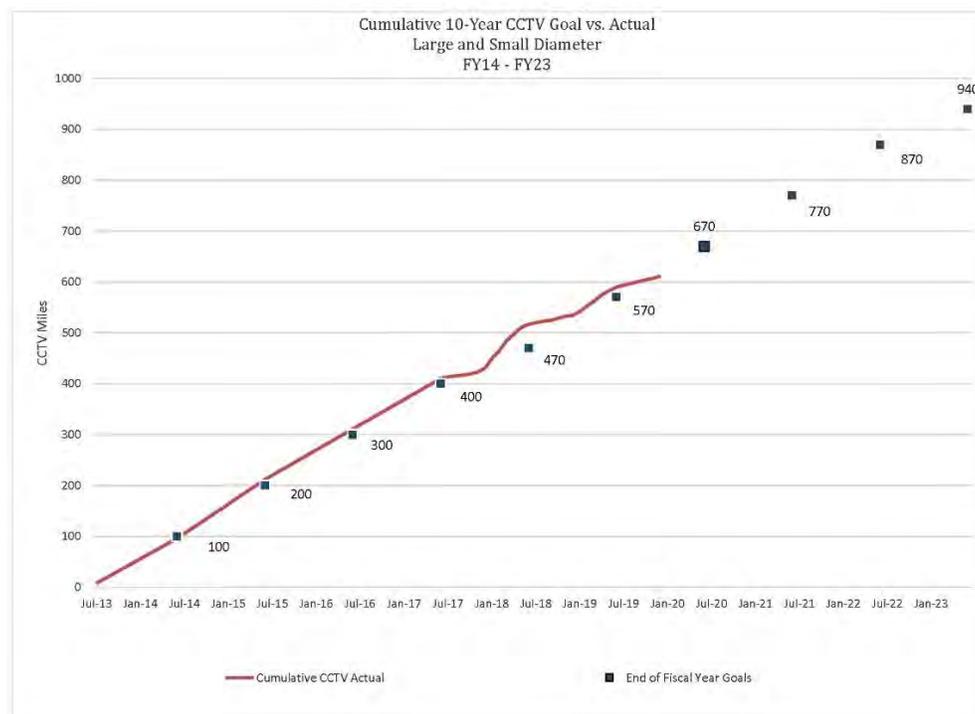
Figure 4 Small Diameter Sewer CCTVed vs. Ten-Year Goal

CMOM Report figures for cleaning and CCTV will continue showing fiscal year (FY) goals in accordance with funding and contracting cycles and actual metrics will reflect work through the end of the calendar year (CY). Figure 4 provides the CCTV goal for a ten-year basis and the actual CCTV inspection through CY2019. The CY2019 portion of this recommendation is complete.

This is an on-going program. The following recommendation is made in the FY2013 CMOM Report: “CCTV inspections of the collection system as follows: 1) Small diameter main lines less than 15”: In four of five years, televise approximately 5% per year of the small diameter system. Televise high risk lines based on current Asset Management Plan and subsequent in-house analysis. 2) Large diameter lines 15” and larger: Every fifth year, televise as much as possible acknowledging access limitations of the unlined concrete lines 15” and larger. Anticipated schedule: 3) FY2014-17: 5% of the small diameter each year. 2) FY18: Large diameter unlined concrete pipe.”

1. FY21: 5% of the small diameter.
2. FY22: 5% of the small diameter.
3. FY23: Large diameter unlined concrete pipe.
4. FY24: 5% of the small diameter.
5. FY25: 5% of the small diameter.
6. FY26: 5% of the small diameter.

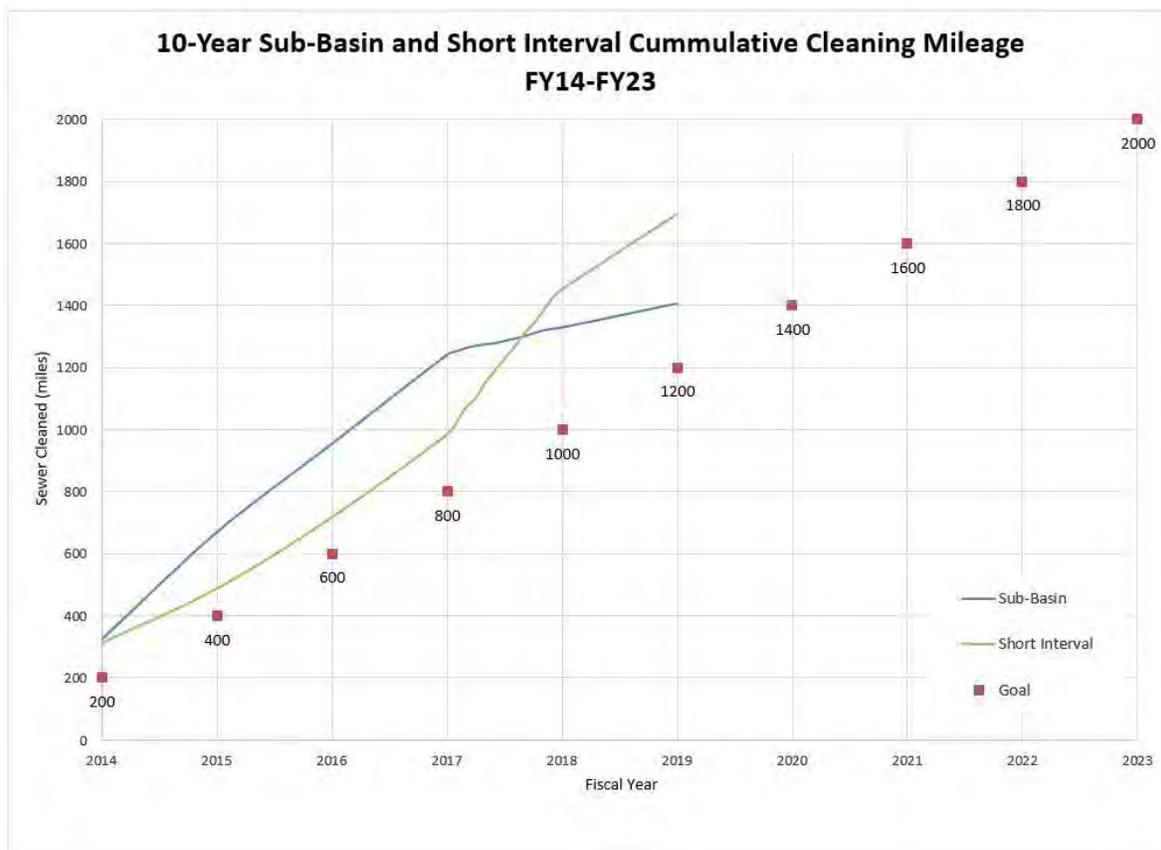
Figure 5 Small Diameter Sewer Cleaned vs. Ten-Year Goal

CMOM Report figures for cleaning and CCTV will continue showing fiscal year (FY) goals in accordance with funding and contracting cycles and actual metrics will reflect work through the end of the calendar year (CY). As shown Figure 5, the Water Authority is ahead of its goal to clean then entire system once in ten years through the Sub-Basin program.

This is an on-going program. The following recommendation is made in the FY2013 CMOM Report: “The Water Authority will establish and monitor a goal of cleaning all gravity small diameter lines every ten years. (This will be accomplished through the existing Sub-Basin program.) The Water Authority will continue the program of high-frequency maintenance of known problem locations within the system. (This will be accomplished through the existing Short Interval program.) The frequency of Short Interval cleaning will vary in accordance with system performance and risk factors, maintenance history, and the latest maintenance findings.”

The Sub-Basin program and associated ten-year cleaning goal remain in place. While meeting this CMOM commitment for Sub-Basin cleaning, the Collection Section has increased Short Interval cleaning.

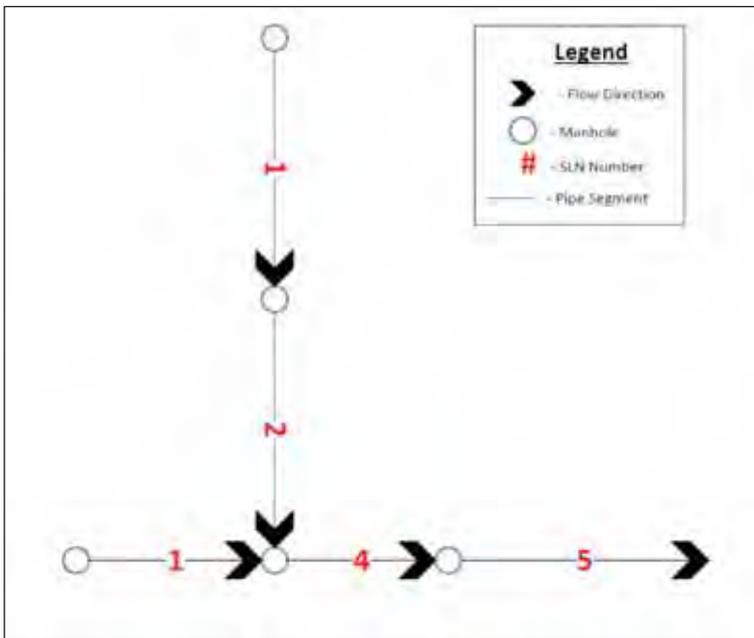
Figure 1. Segment Loading Number (SLN) Example

As described in Figure 1 (below), each manhole-to-manhole segment is assigned an SLN. The number of segments was determined for each SLN and the length of the segments also was determined. Note the similarity of the composition by SLN for both count and length. The sewer troubles that had occurred over the past 6.25 years for each segment were assigned to the corresponding SLN. Sewer trouble rates were thereby determined for the upper and lower portions of the sub-basins studied.

The SLN identifies the number of segments loading to a pipe segment connecting two manholes. In this example, the SLN is 1 for the two dead-end pipe segments. Downstream SLNs are the sum of the SNLs loading to a manhole plus 1. SLNs were assigned using a simple GIS-based process.

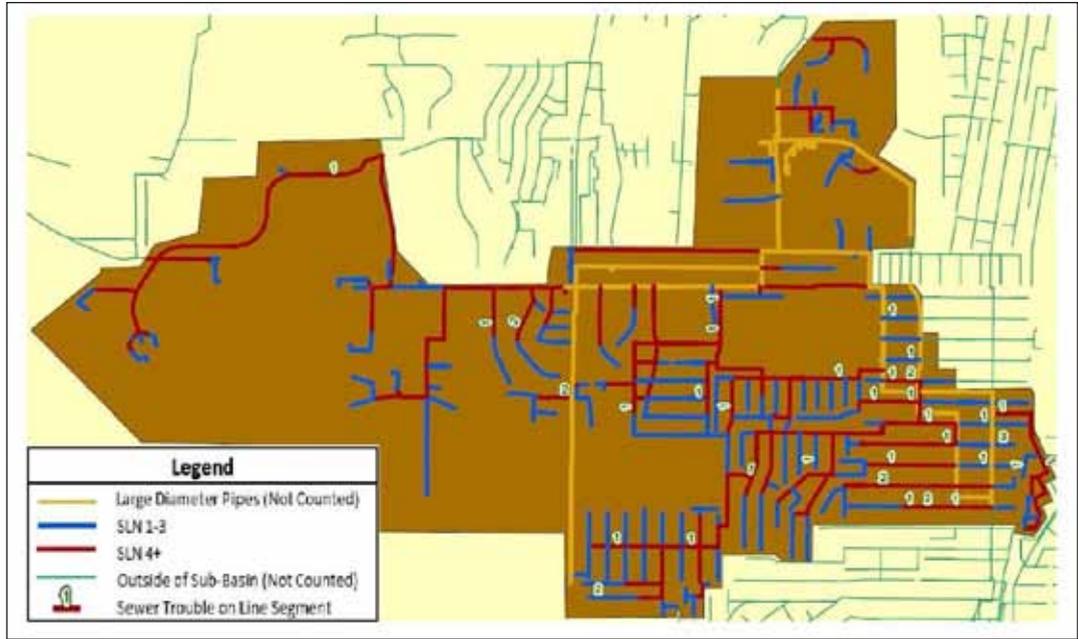
**Figure 2. An Area-Wide Basin**

Sub-basins form the water authority's area-wide cleaning program for 200- to 300-mm (8- to 12-in.) pipes, which are cleaned top-to-bottom every 10 years. This is one of the three studied sub-basins. Shown are the upper and lower portions as determined by SLN as well as the sewer troubles on each segment. Pipes 375 mm (15 in.) and larger are not included in the area-wide cleaning program and were not assigned SLNs.

The water authority utilizes an area-wide cleaning program consisting of 49 sub-basins that are cleaned, top to bottom, no less than every 10 years. Area-wide and hot-spot cleaning programs are gravity pipe cleaning programs utilized by the water authority, along with most utility programs, to clean the entire system and known problem locations, respectively.

Only small diameter pipes — defined as 300-mm (12-in.) and smaller — are included in the area-wide and hot-spot cleaning programs. The small diameter lines make up approximately 90% of the total length of the gravity pipes. The water authority has a separate large diameter pipe cleaning program.

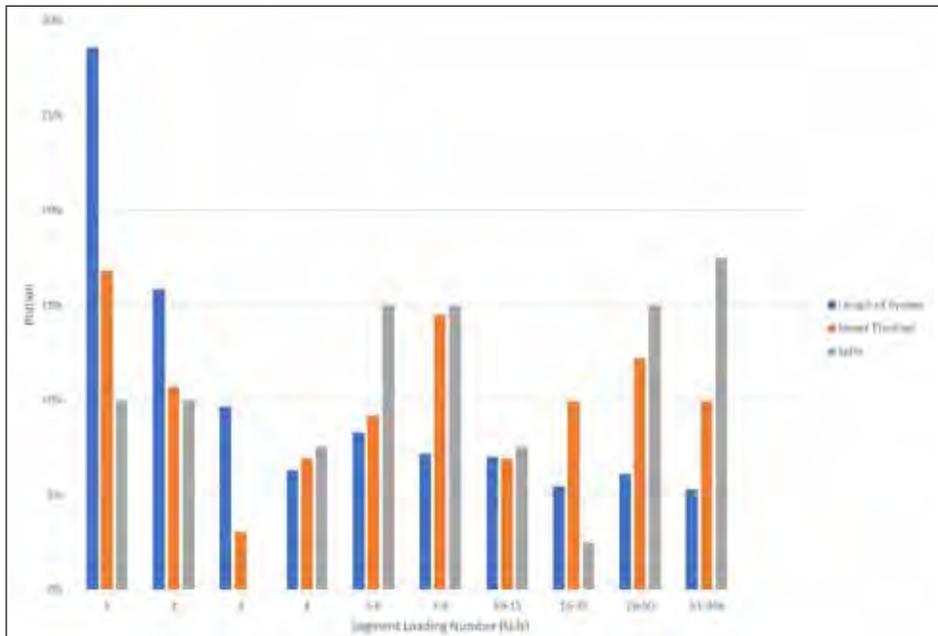
**Figure 3. Portion of Pipe Segments by SLN Versus Portion of Sewer Troubles**

Sewer troubles and spills are not evenly distributed throughout the system. At one extreme are the SLN = 1 segments which make up 28.6% of the system but only experience 10.0% of costly spills and 16.8% of total sewer troubles. At the other extreme, segments with an SLN = 51 and greater make up only 5.6% of the system, but experience 9.9% of the trouble and 17.5% of the spills. The spill rate, defined as number per year per 100 mile of pipe is 1.4 for SLN = 1 and 12.4 for SLN = 51 and greater.

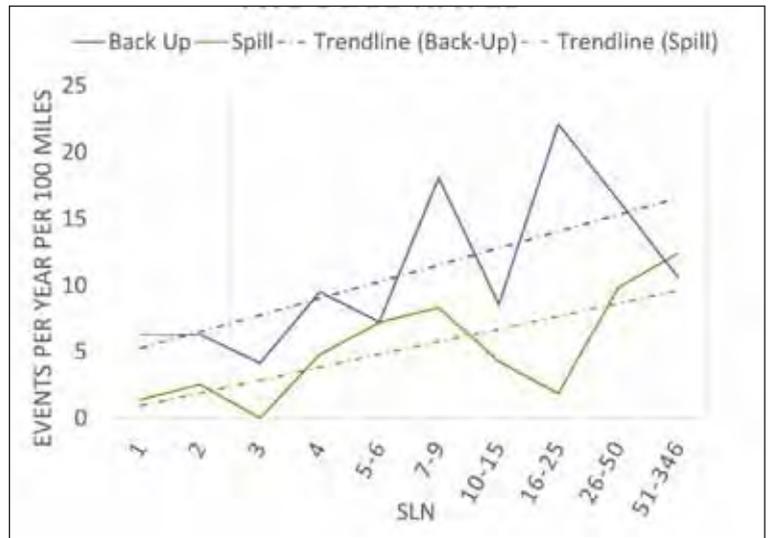
**Figure 4. Back-Up and Spill Rates by SLN**

**Both back-up and spill rates correspond and increase with SLN. Back-ups are sewer blockages that do not result in a spill. Spills may be to the environment or private property. The rate is the number of occurrences per year per 160.9 km (100 mi) of system.**
