# CMOM ANNUAL REPORT FY2016

September 30, 2016

## **Capacity, Management, Operations and Maintenance (CMOM) Plan Overview**

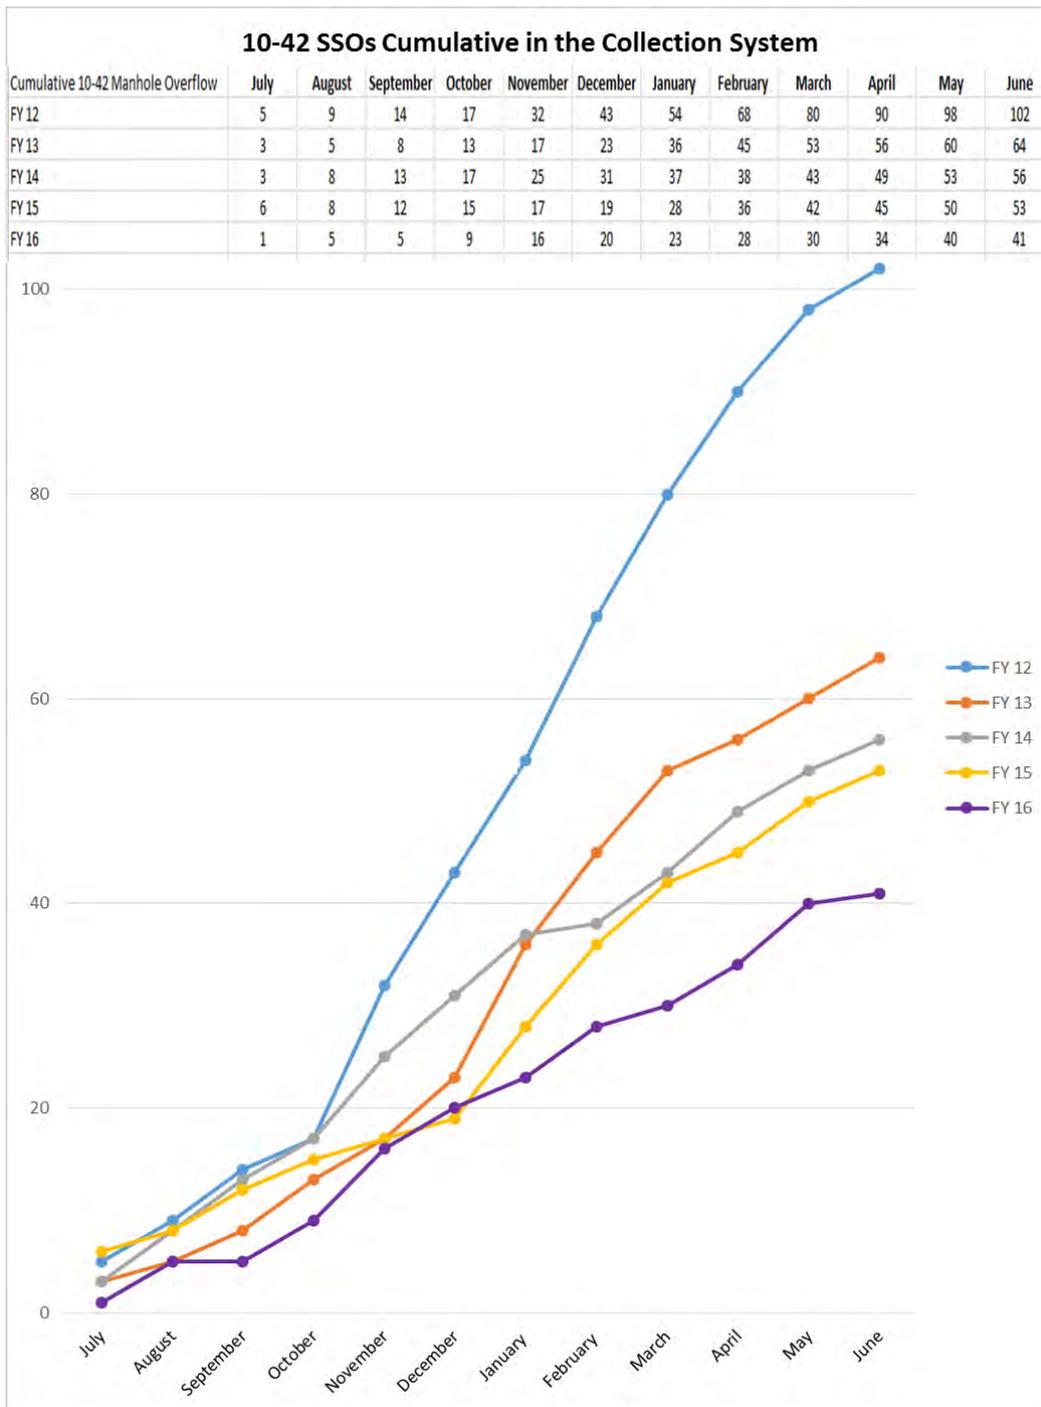
**Figure 1 FY2016 Reportable SSOs**

Figure 1 shows the cumulative 10-42s by month for FY2012-16.

The SSO Rate is defined as 100 times the number of SSOs in a year divided by the miles of sewer in the system. The Water Authority system has a total of approximately 2,414 miles of line (p. 8 of the Self-Audit). The SSO rate is therefore 4.5, 2.8, 2.5, 2.3 and 1.7 for FY2012-16 respectively.

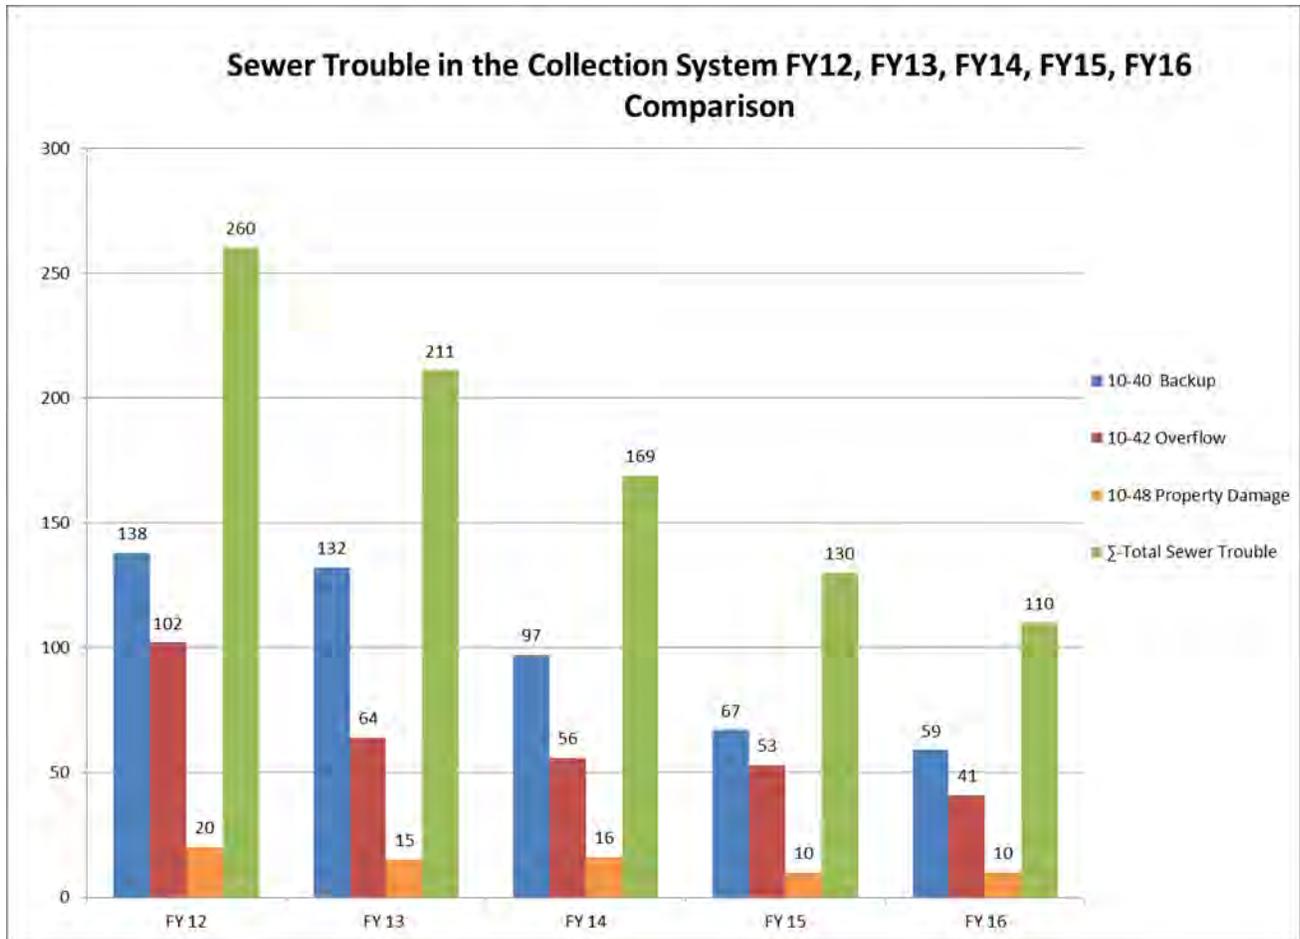
**Figure 2 Sewer Trouble Comparison**

Figure 2 shows the total sewer troubles, i.e. 10-40s, -42s, and -48s by year for FY2012-16. This graph does not include 10-48s due to “burps” which are not due to a blockage or other failure resulting in the overflow of sewage. Instead, air displaced during the Vactor jetting cleaning can under certain circumstances force out the water in the home fixture P-traps, e.g. toilets and sinks. These sometimes result in claims and are therefore included in the Property Damage totals for completeness and consistency. The burps for FY2012-16 have been 1, 0, 5, 5, and 9 respectively. The increase in burps is possibly due to more aggressive efforts to thoroughly clean the lines. If so, it is possible the increased burps are associated with the decrease of 10-42s over the same time. The burps are identified in Appendix 1.

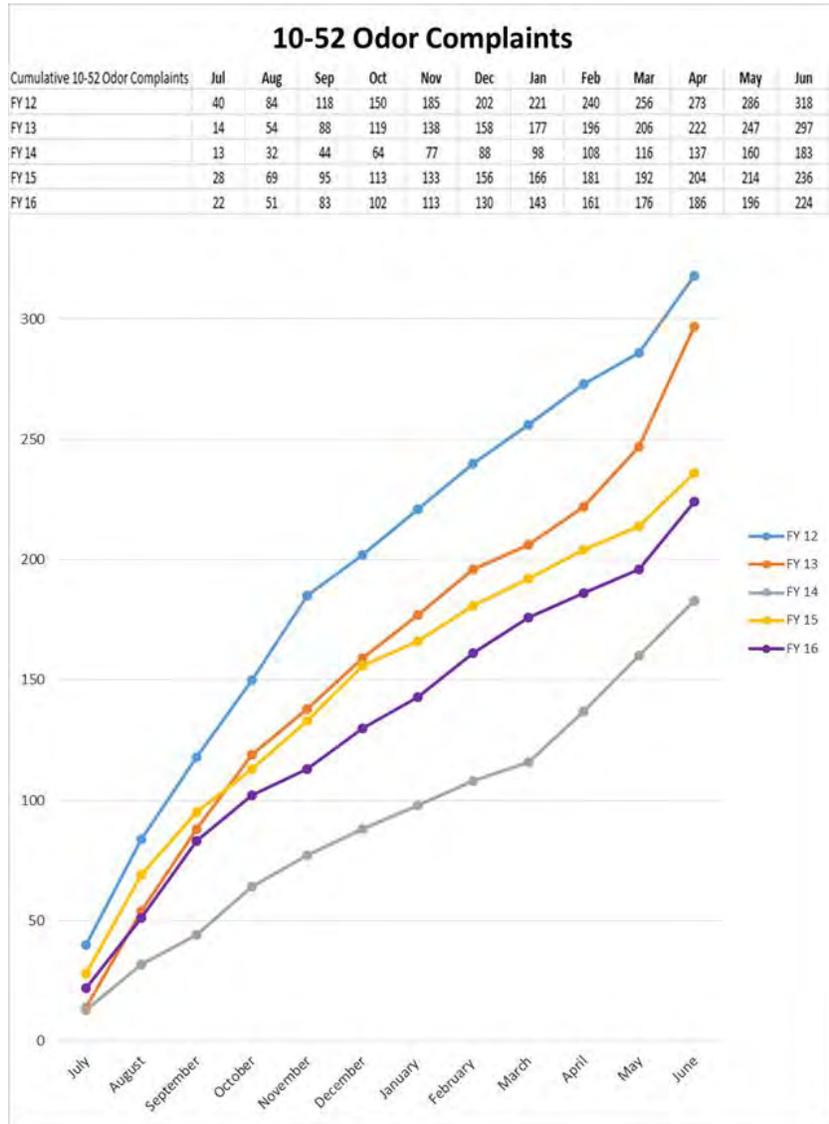
**Figure 3 Odor Complaints**

Odor control is a major issue in warm-weather systems such as Albuquerque’s. A high correlation has been demonstrated between odor complaints and the sewage temperature (analysis of FY11 & FY12 temperature vs. odor complaint data,  $r = 0.89$ ,  $p < 0.02$ ). Odor complaints are also known as a 10-52. The following graphic shows the odor complaints received by the Water Authority in FY2012 through FY2016. All odor complaints received are

included in this graphic; however, study has indicated that approximately 3/4 of the complaints received originate in the private and not the public system.

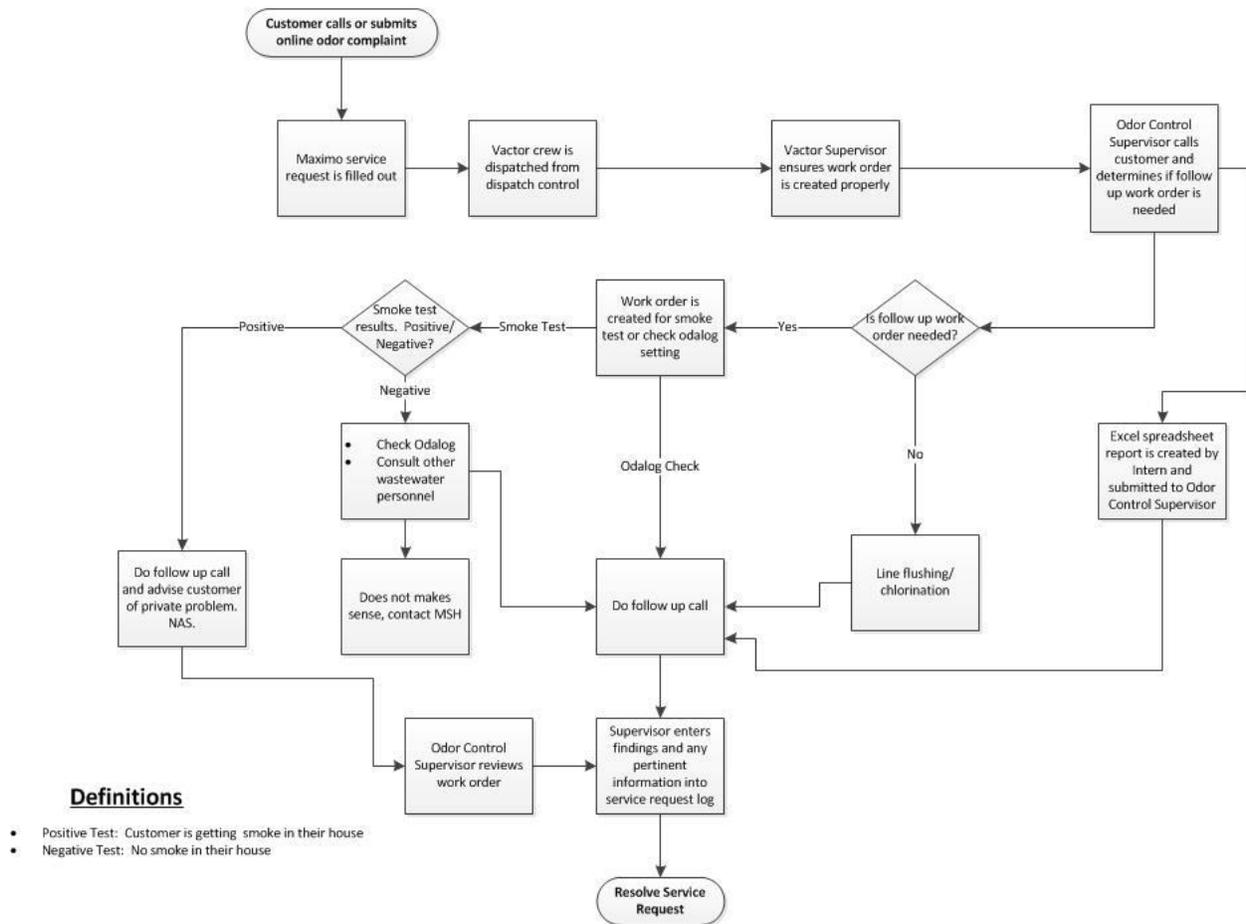
Figure 4 Odor Complaint Flow Chart

The following flow chart describes the process followed by the Water Authority in response to an odor complaint. This specific process in the immediate response and the follow-up to odor complaints is due to the importance placed on customer service. Also, the Water Authority has found that some odor complaints are due to a blockage prior to an overflow; therefore, a quick response can prevent an SSO.

## 10-52 Odor Complaint Flow Chart

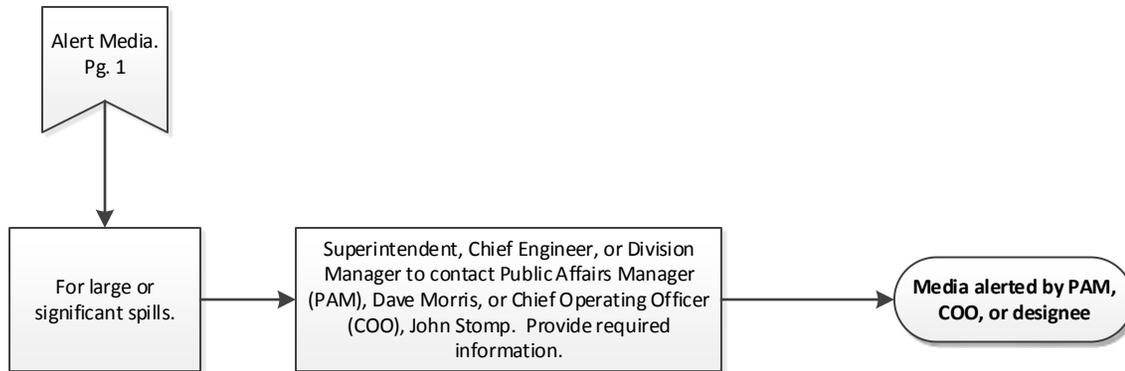
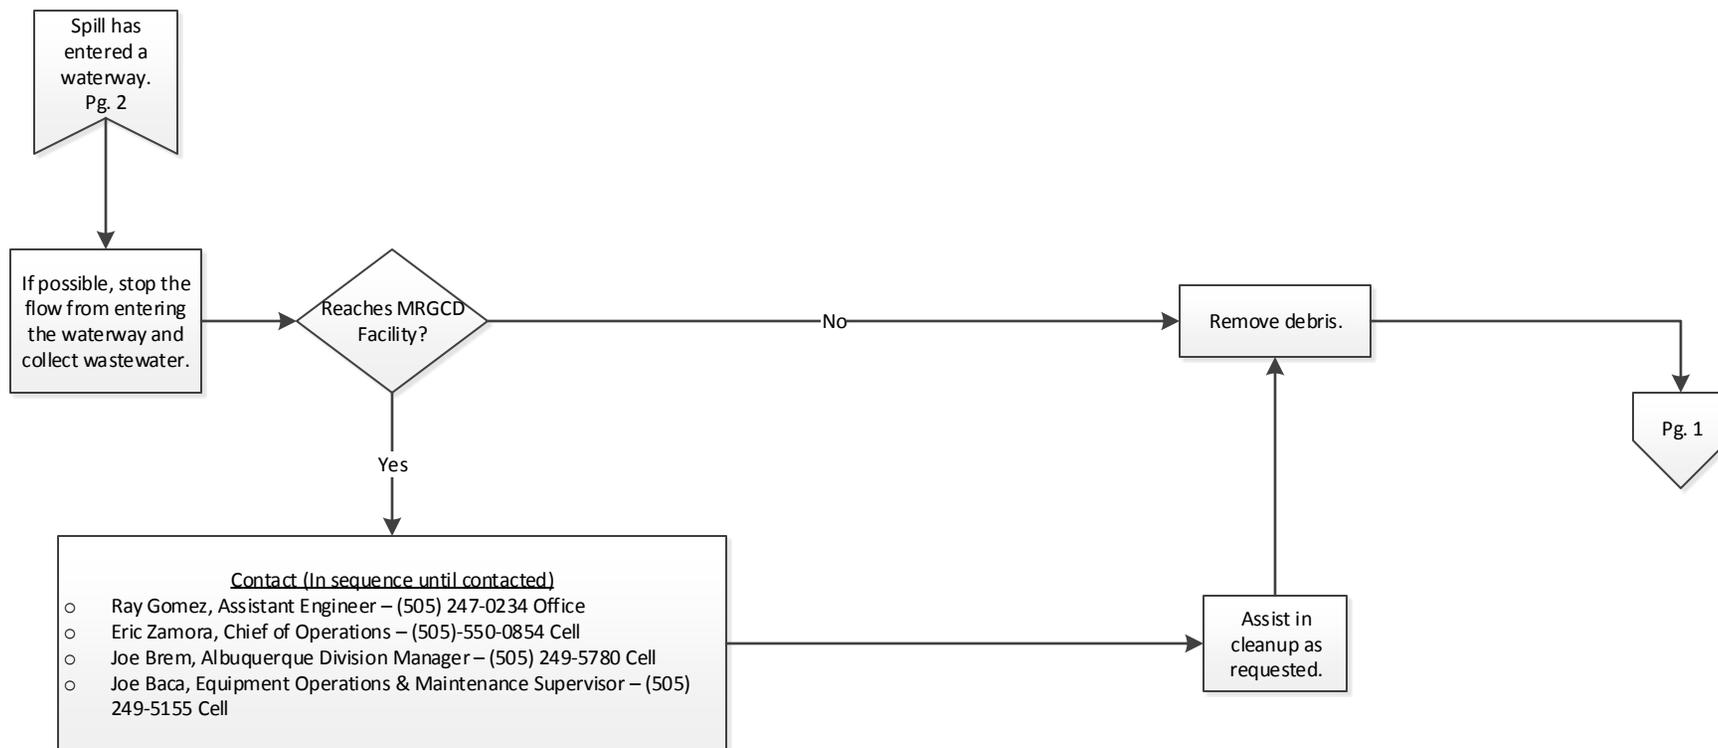
Note: Process shown is for typical spills. Some spills may require a joint response with the City of Albuquerque in which the spill is captured, treated, and determined appropriate for release.
