# CMOM ANNUAL REPORT FY2017

## Capacity, Management, Operations and Maintenance (CMOM) Plan Overview

In accordance with National Pollutant Discharge Elimination System (NPDES) Permit No. NM0022250 (Permit), the Albuquerque Bernalillo County Water Utility Authority (Water Authority) prepared a Capacity, Management, Operations and Maintenance (CMOM) Plan with Emphasis on the Fats, Oils and Grease (FOG) Policy. The effective date of the Water Authority's permit is October 1, 2012.

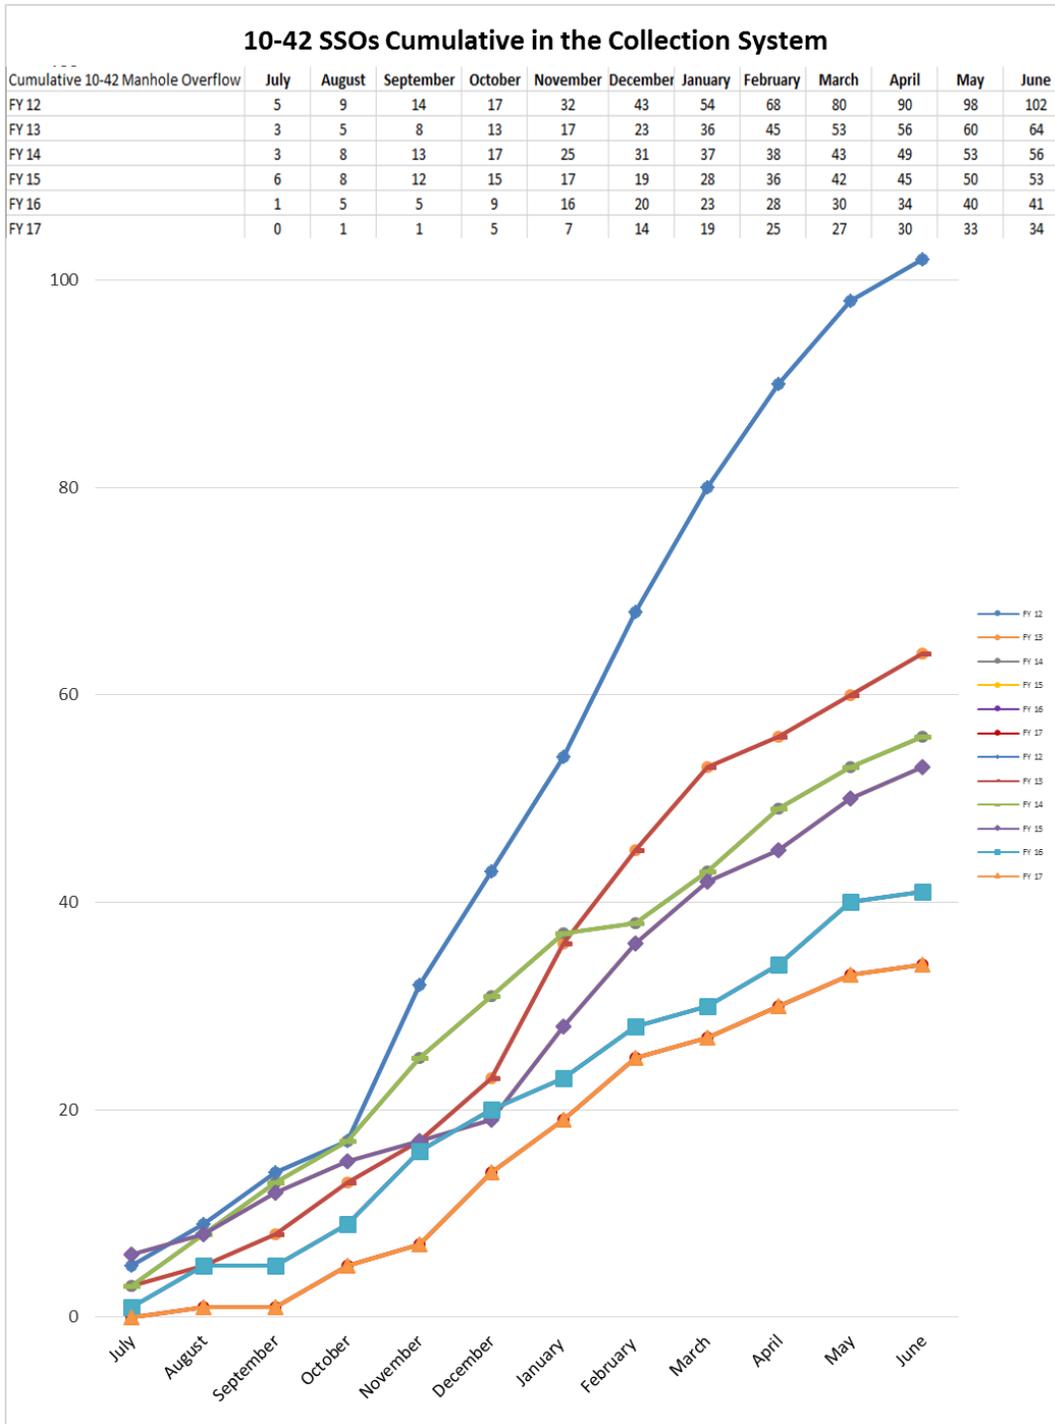
**Figure 1 Reportable SSOs**

Figure 1 shows the cumulative 10-42s by month for FY2012-17.

The SSO Rate is defined as 100 times the number of SSOs in a year divided by the miles of sewer in the system. The Water Authority system has a total of approximately 2,414 miles of line (p. 8 of the Self-Audit). The SSO rate is therefore 4.5, 2.8, 2.5, 2.3, 1.7, and 1.4 for FY2012-17 respectively.

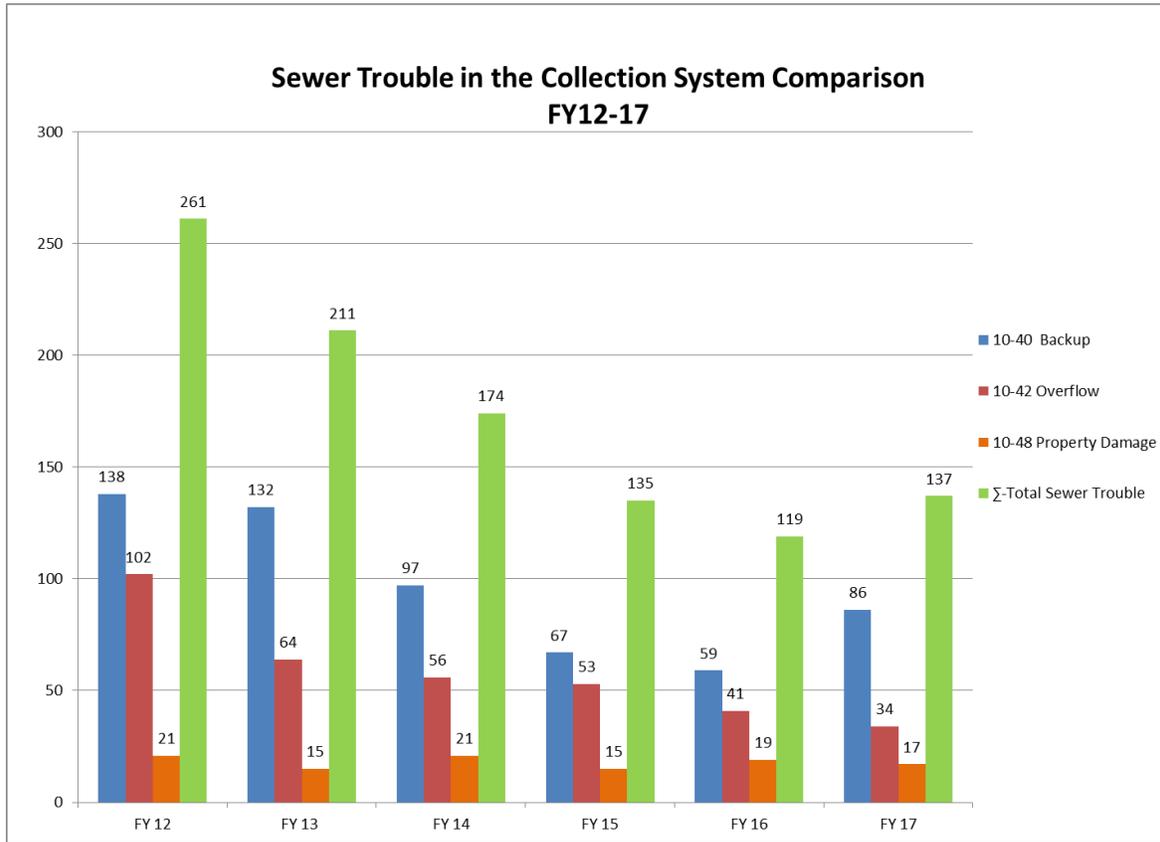
**Figure 2 Sewer Trouble Comparison**

Figure 2 shows the total sewer troubles, i.e. 10-40s, -42s, and -48s by year for FY2012-17. This graph does not include 10-48s due to “burps” which are not due to a blockage or other failure resulting in the overflow of sewage. Instead, air displaced during the Vactor jetting cleaning can under certain circumstances force out the water in the home fixture P-traps, e.g. toilets and sinks. These sometimes result in claims and are therefore included in the Property Damage totals for completeness and consistency. The burps for FY2012-17 have been 1, 0, 5, 5, 9, and 3 respectively. The burps are identified in Appendix 1.

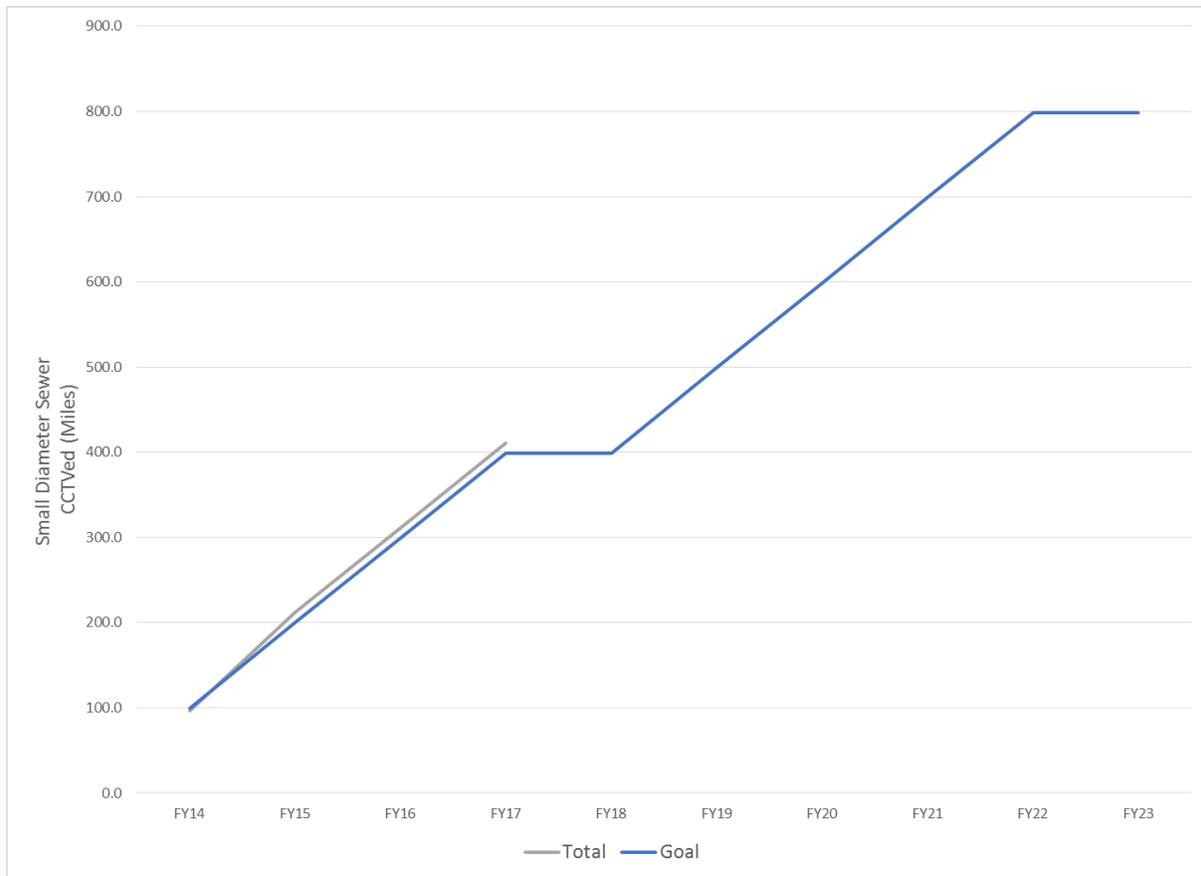
**Figure 3 Small Diameter Sewer CCTVed vs. Ten-Year Goal**

The FY2017 portion of this recommendation is complete. It is currently estimated that that the system includes 1996 miles of small diameter gravity pipe. Figure 3 provides the CCTV goal for a ten-year basis and the actual CCTV inspection for the first four years.

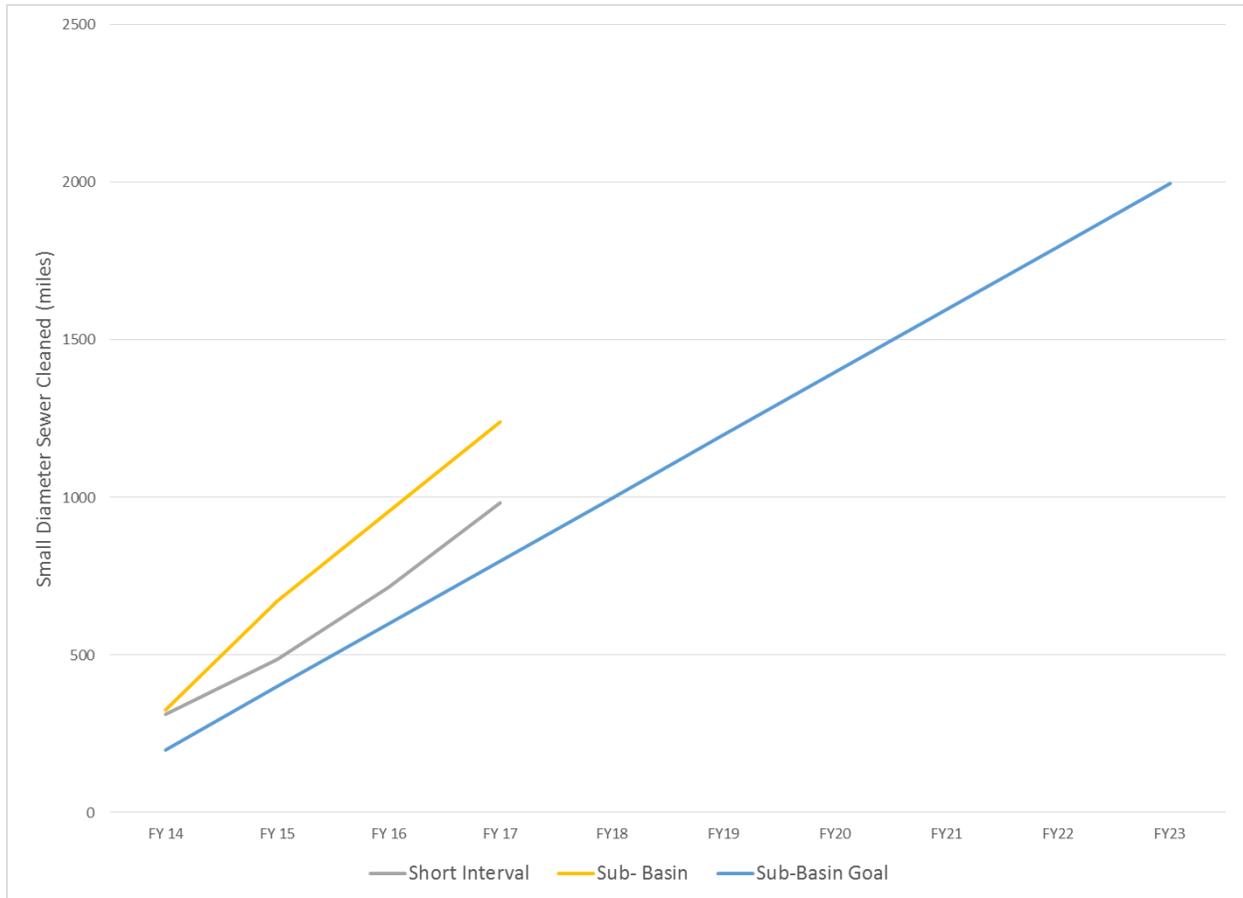
**Figure 4 Small Diameter Sewer Cleaned vs. Ten-Year Goal**

The FY2017 portion of this recommendation is complete. In FY2017, the Water Authority cleaned approximately 286.9 miles under the Sub-Basin program. This is equal to approximately 14.4% of the small diameter system which exceeds the 10% pace implicit in cleaning every ten years. Likewise, the Short Interval cleaning program was maintained with approximately an additional 266.6 miles cleaned.

As shown Figure 4 below, the Water Authority is ahead of its goal to clean then entire system once in ten years through the Sub-Basin program.

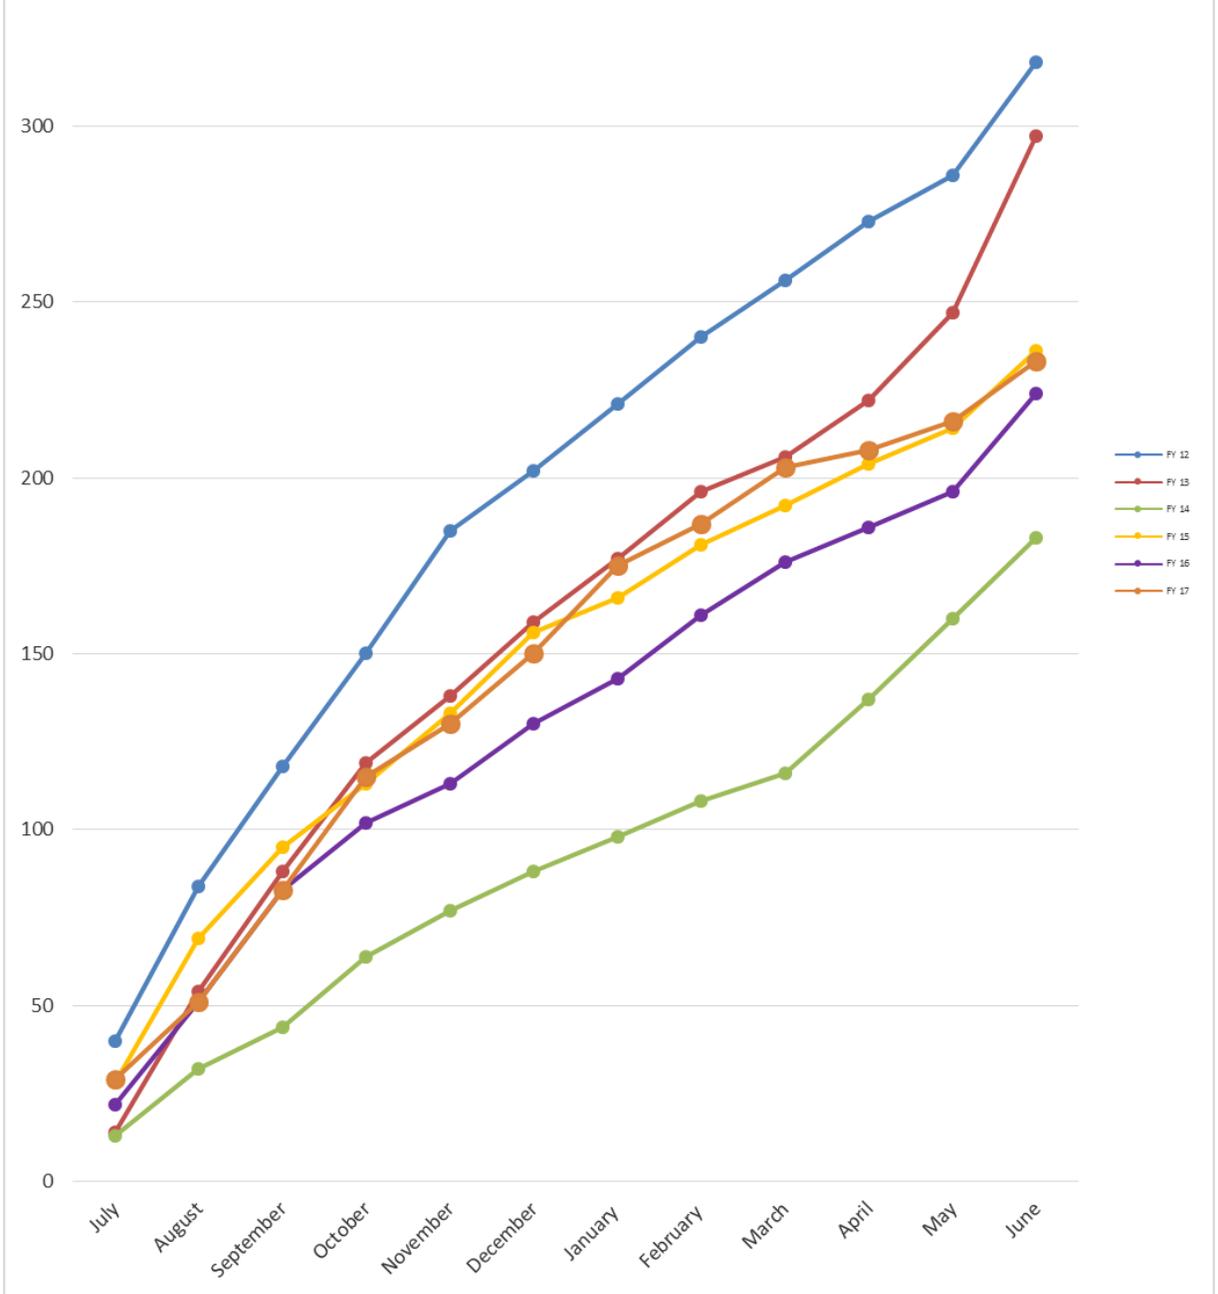
**Figure 5 Odor Complaints**

Cumulative 10-52 Odor Complaints	Jul	Aug	Sep	Oct	Nov	Dec	Jan	Feb	Mar	Apr	May	Jun
FY 12	40	84	118	150	185	202	221	240	256	273	286	318
FY 13	14	54	88	119	138	158	177	196	206	222	247	297
FY 14	13	32	44	64	77	88	98	108	116	137	160	183
FY 15	28	69	95	113	133	156	166	181	192	204	214	236
FY 16	22	51	83	102	113	130	143	161	176	186	196	224
FY 17	29	51	83	115	130	150	175	187	203	208	216	233

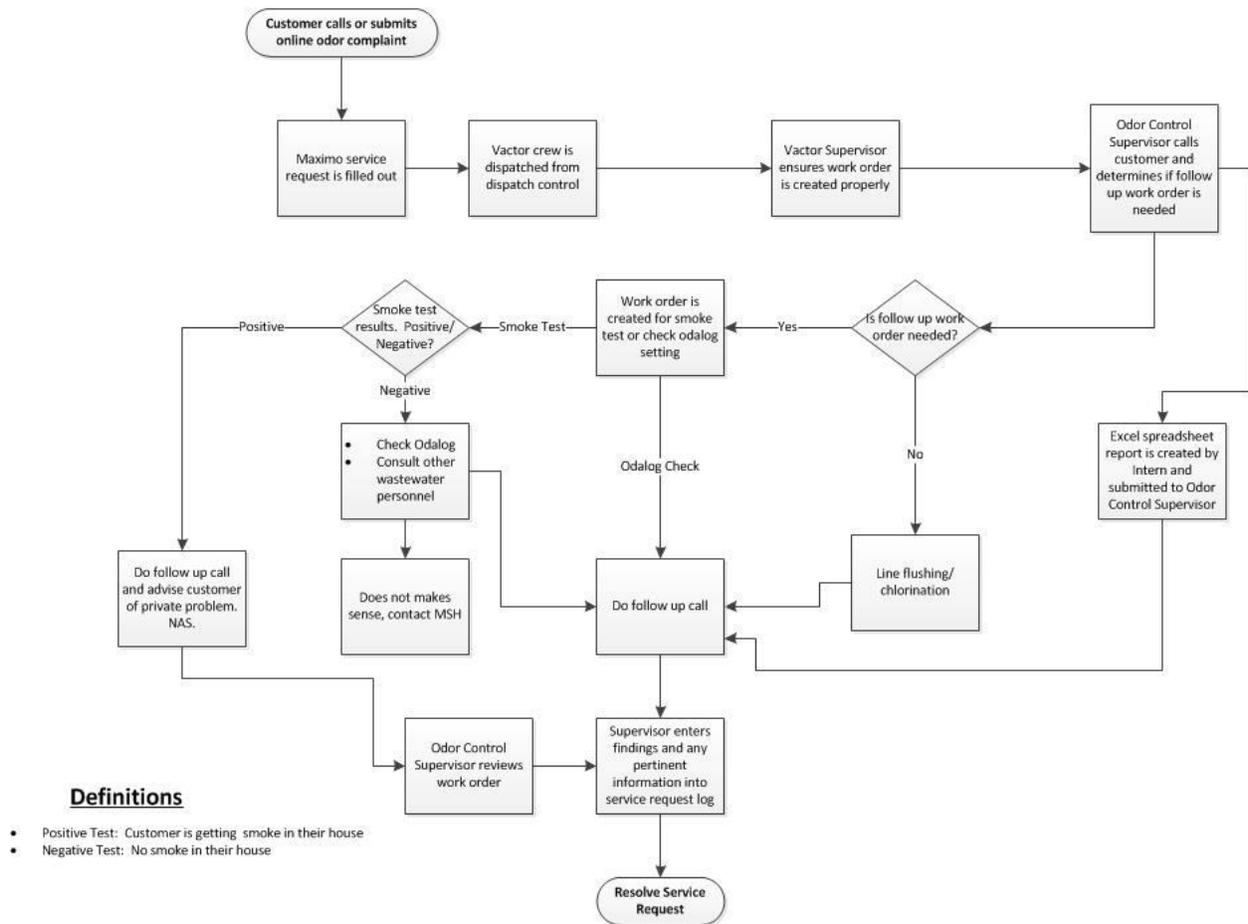
Figure 6 Odor Complaint Flow Chart

The following flow chart describes the process followed by the Water Authority in response to an odor complaint. This specific process in the immediate response and the follow-up to odor complaints is due to the importance placed on customer service. Also, the Water Authority has found that some odor complaints are due to a blockage prior to an overflow; therefore, a quick response can prevent an SSO.
