CMOM ANNUAL REPORT CY2020

Capacity, Management, Operations and Maintenance (CMOM) Plan Overview

In accordance with National Pollutant Discharge Elimination System (NPDES) Permit No. NM0022250 (Permit), the Albuquerque Bernalillo County Water Utility Authority (Water Authority) prepared this Capacity, Management, Operations and Maintenance (CMOM) Plan. The Permit was renewed in CY2019 with an effective date of December 1, 2019.

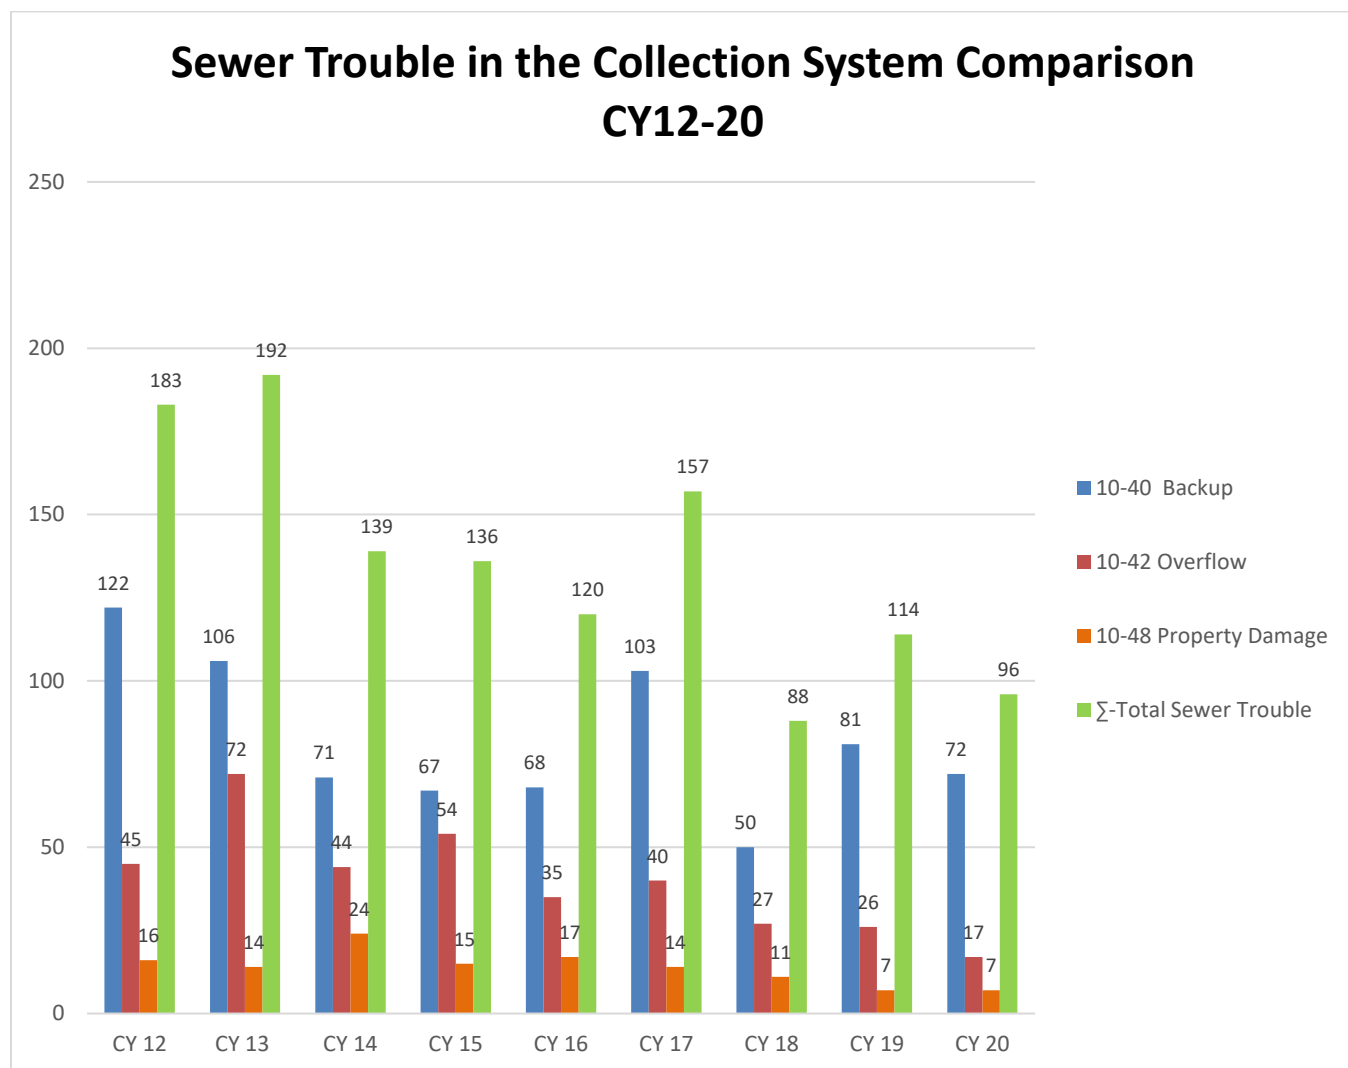
Figure 2 shows the total sewer troubles, i.e. 10-40s, -42s, and -48s by year for CY2012-20. This graph does not include 10-48s due to “burps” which are not due to a blockage or other failure resulting in the overflow of sewage. Instead, air displaced during the Vactor jetting cleaning can under certain circumstances force out the water in the home fixture P-traps, e.g. toilets and sinks. These sometimes result in claims and are therefore included in the Property Damage totals for completeness and consistency. There was only one burp during CY 2020. This burp is identified in Appendix 1.

Figure 2 Sewer Trouble Comparison

Appendix 1 identifies all 10-42s and 10-48s, and the overflows that resulted in both a 10-42 and a 10-48. When documenting the number of Sewer Troubles of different types, for example in Figure 1 and Figure 2, the 10-42 item includes all overflows that may impact surface waters, including those that also had property damage; the 10-48 item includes overflows that only resulted in property damage. This prevents double-counting the number of overflow occurrences.

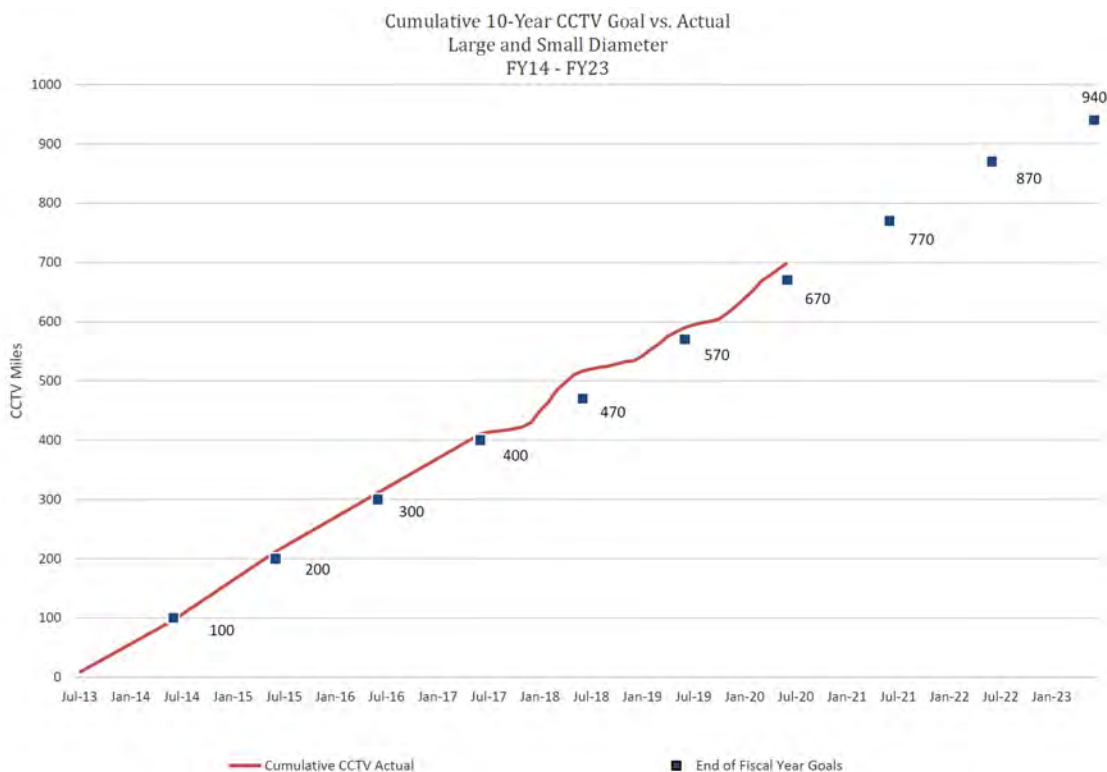
Figure 3 Small Diameter Sewer CCTVed vs. Ten-Year Goal

CMOM Report figures for cleaning and CCTV will continue showing fiscal year (FY) goals in accordance with funding and contracting cycles and actual metrics will reflect work through the end of the calendar year (CY). Figure 4 provides the CCTV goal for a ten-year basis and the actual CCTV inspection through CY2020. The CY2020 portion of this recommendation is complete. The CCTV program will continue. Anticipated schedule:

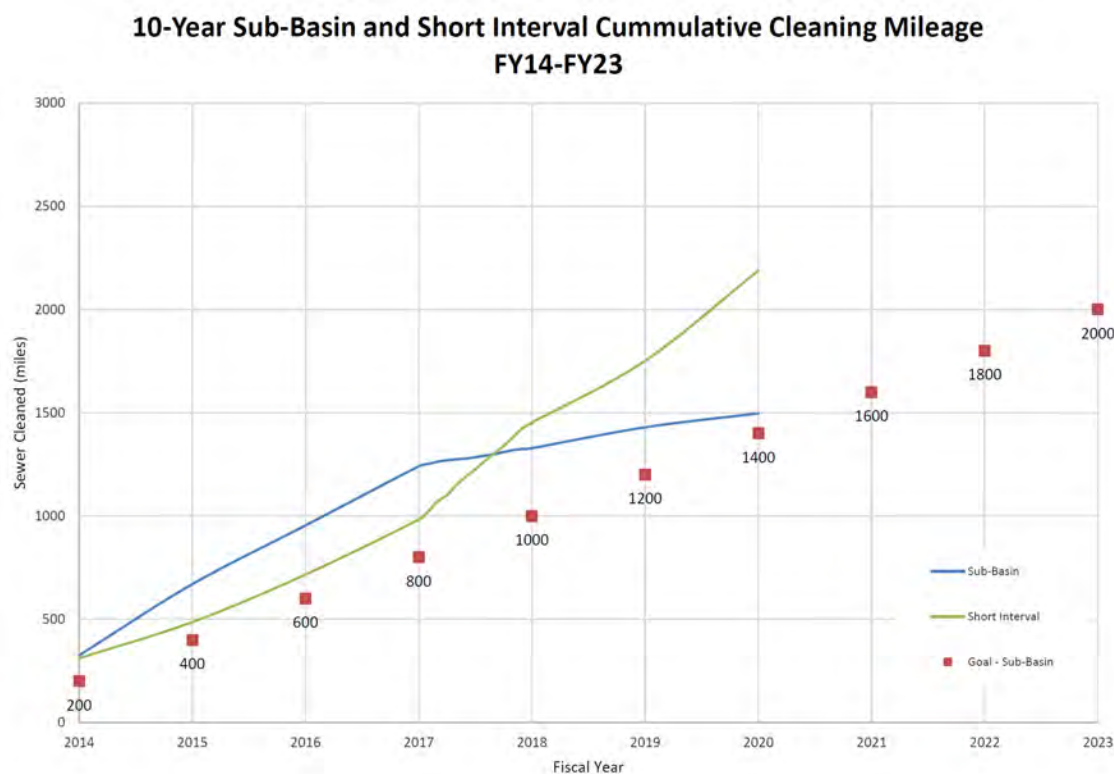
Figure 4 Small Diameter Sewer Cleaned vs. Ten-Year Goal

This is an on-going program. The following recommendation is made in the FY2013 CMOM Report: “The Water Authority will establish and monitor a goal of cleaning all gravity small diameter lines every ten years. (This will be accomplished through the existing Sub-Basin program.) The Water Authority will continue the program of high-frequency maintenance of known problem locations within the system. (This will be accomplished through the existing Short Interval program.) The frequency of Short Interval cleaning will vary in accordance with system performance and risk factors, maintenance history, and the latest maintenance findings.”

The Sub-Basin program and associated ten-year cleaning goal remain in place. While meeting this CMOM commitment for Sub-Basin cleaning, the Collection Section has increased Short Interval cleaning.
